A GOLDMINE GOLD A goldmine Gold Mine Sag Mill

Author	Justin Marwick	22 nd August 2016
Reviewed	Brendan Wicks	23 rd August 2016
Client	A goldmine Mining	A goldmine Gold
Inspection Date		17 th August 2016
Order Number	Purchase Order No

NDT and inspection of A goldmine Gold mining's – A goldmine Gold mines Sag Mill girth gear. The principal objective is the detection of fatigue cracking that poses a risk to the continued operation of the ball mill and report significant anomalies.

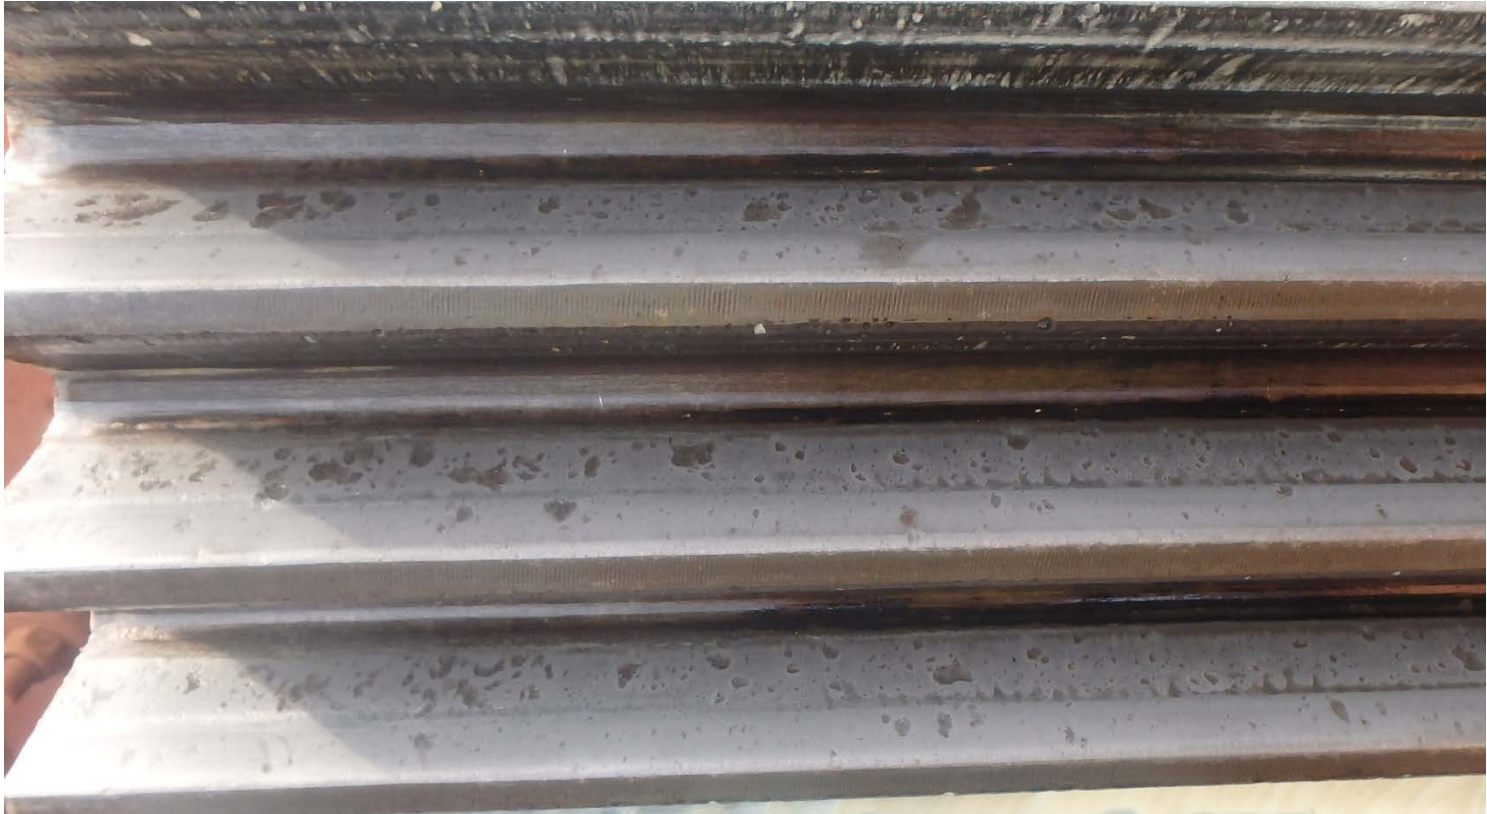
General view of contact flank.

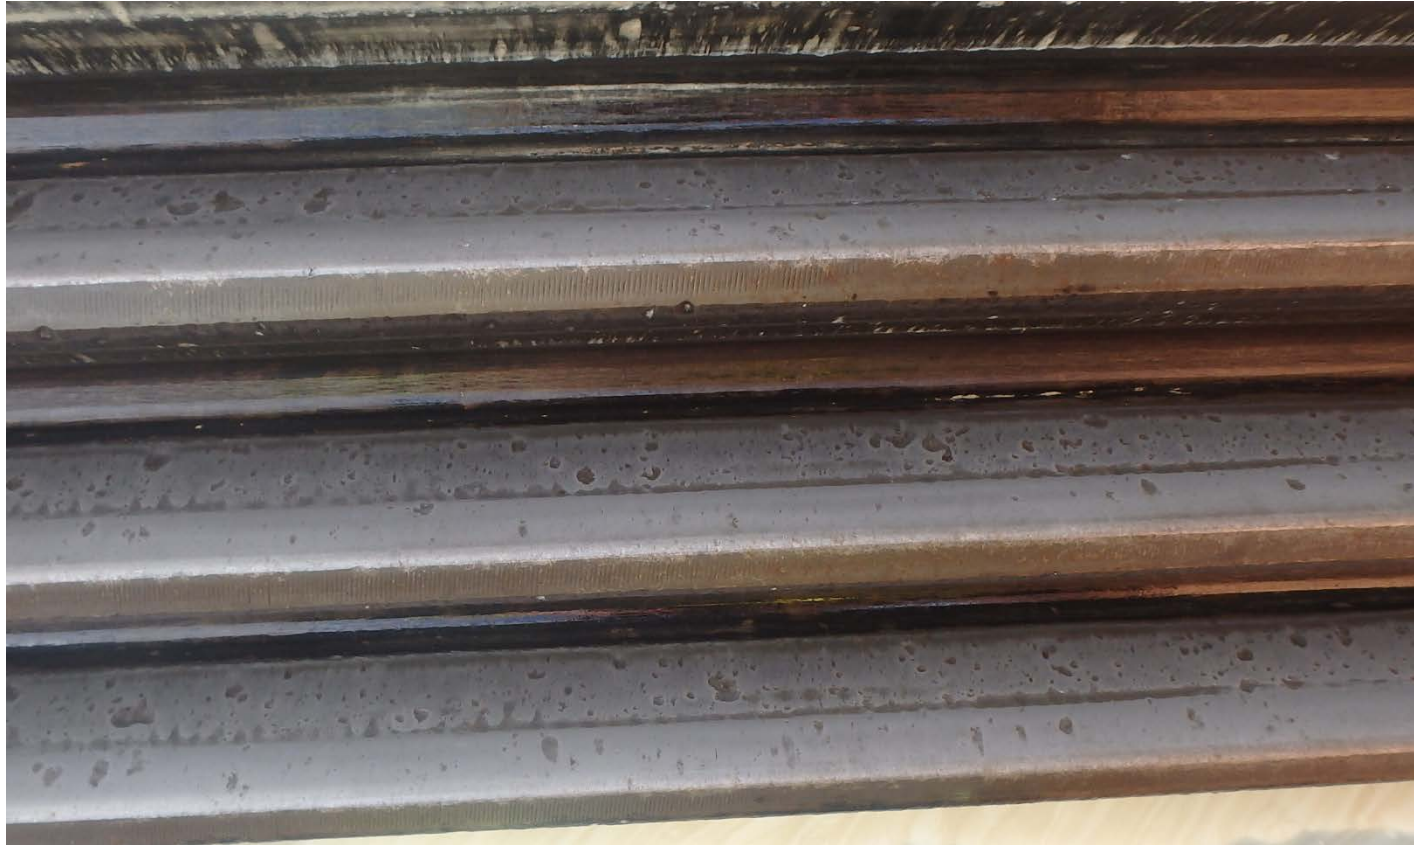
The girth gear has a depressed pitch line. This coincides with a slightly raised pitch line on the pinion gear. This would normally indicate that significant wear has taken place with a relatively soft pinion driving the gear. Wear happens in the addendum and de-dendum areas of the gear set. Once the abrasion or wear has taken place it leaves a high pitch line due to the rolling action of the gears.

General view of contact flank Non Drive End the dark line indicates a depressed pitchline.

It would be advisable to remove the protruding pitchline on the pinion by means of a sander and oilstone. Once the pinion geometry is improved - then the deterioration on the girth gear associated with load concentration will be reduced. In the long run (sometime in the next 1 - 2 years) it would be advisable to do the same for the girth gear and reverse the pinion to provide a good medium term outcome.

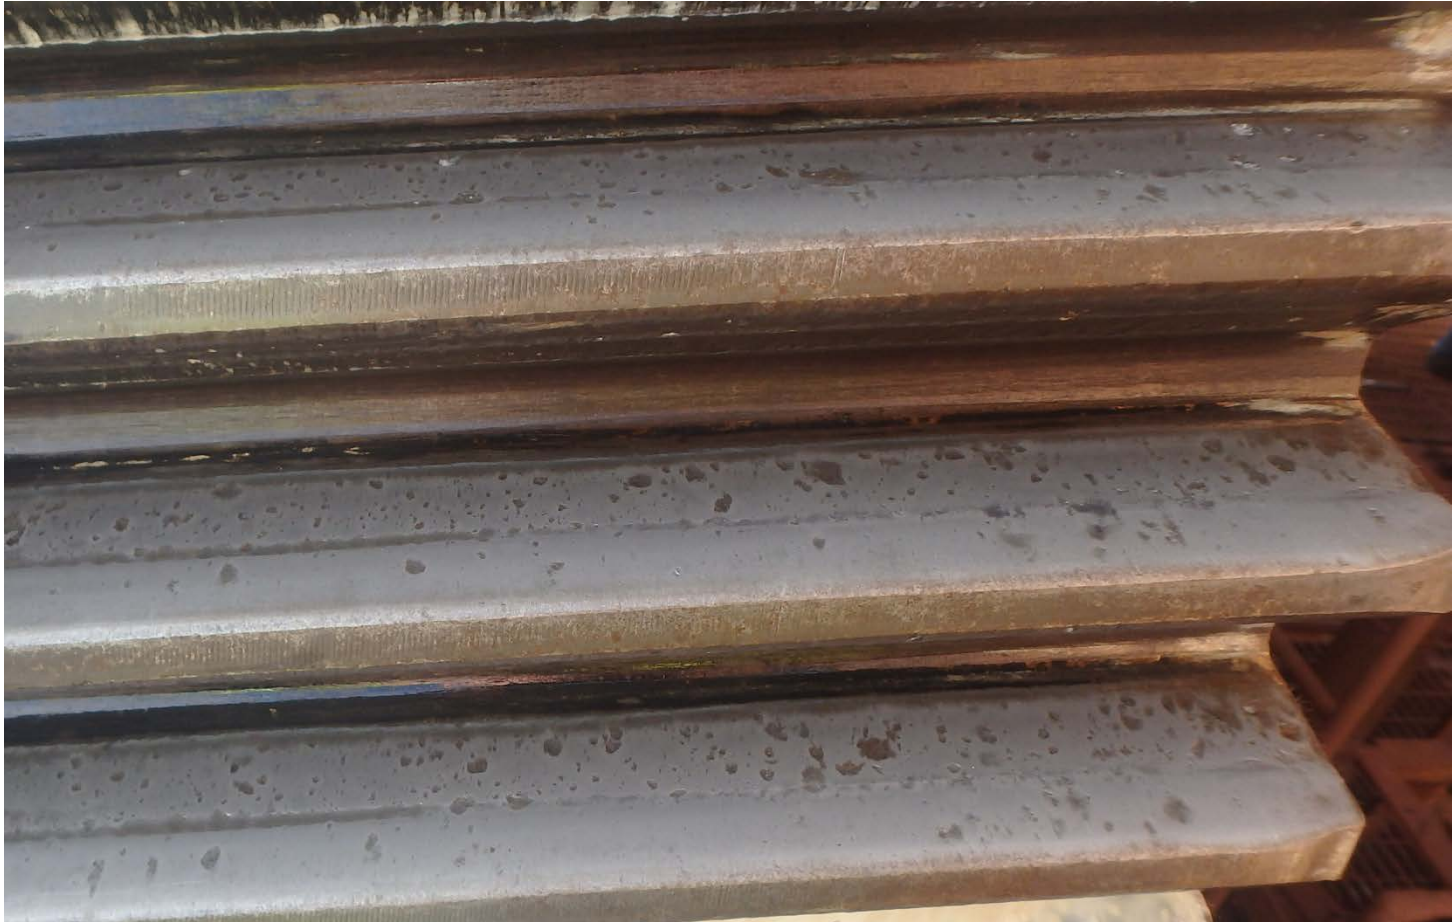
General view of contact flank center region demonstrating more indentations on the dedendum of the tooth.

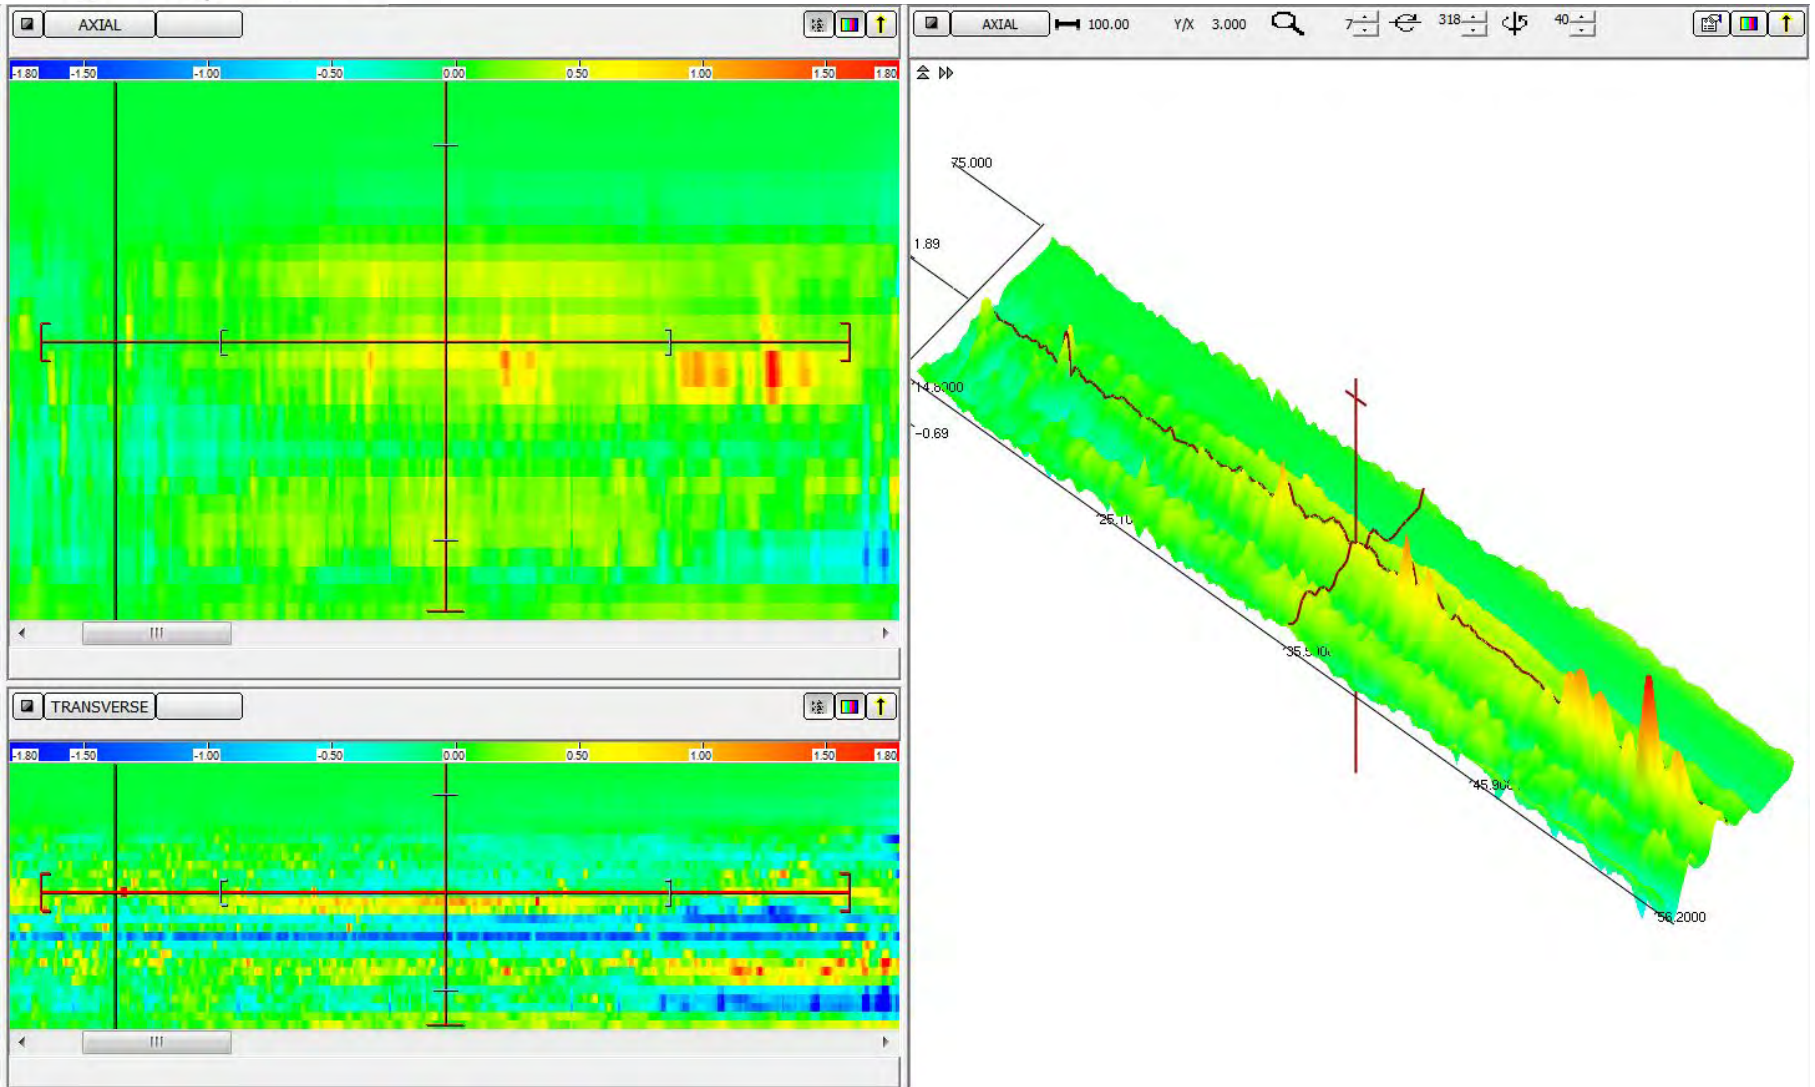
General view contact flank Drive End.

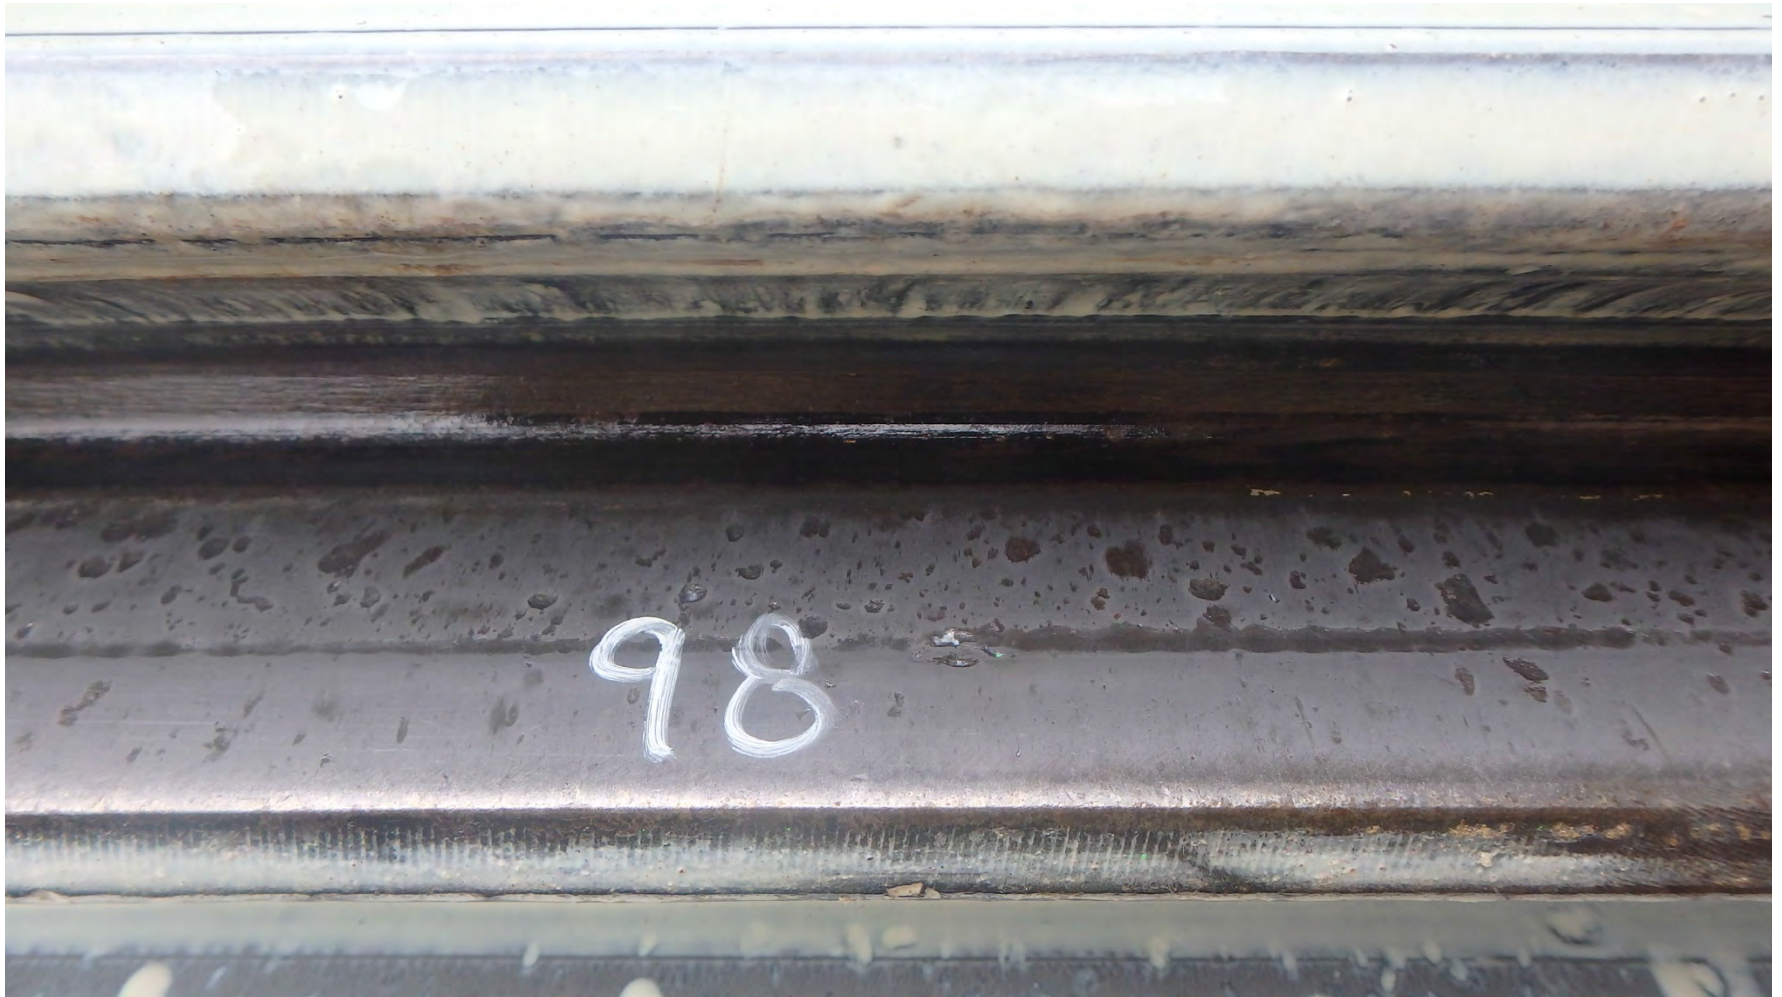
Tooth 196 (pictured above) showing a typical eddy current signal. The eddy current disturbance is greater towards the bottom of the C-scan (the dedendum of the gear tooth). The gain has been adjusted to largely filter out the indentations.

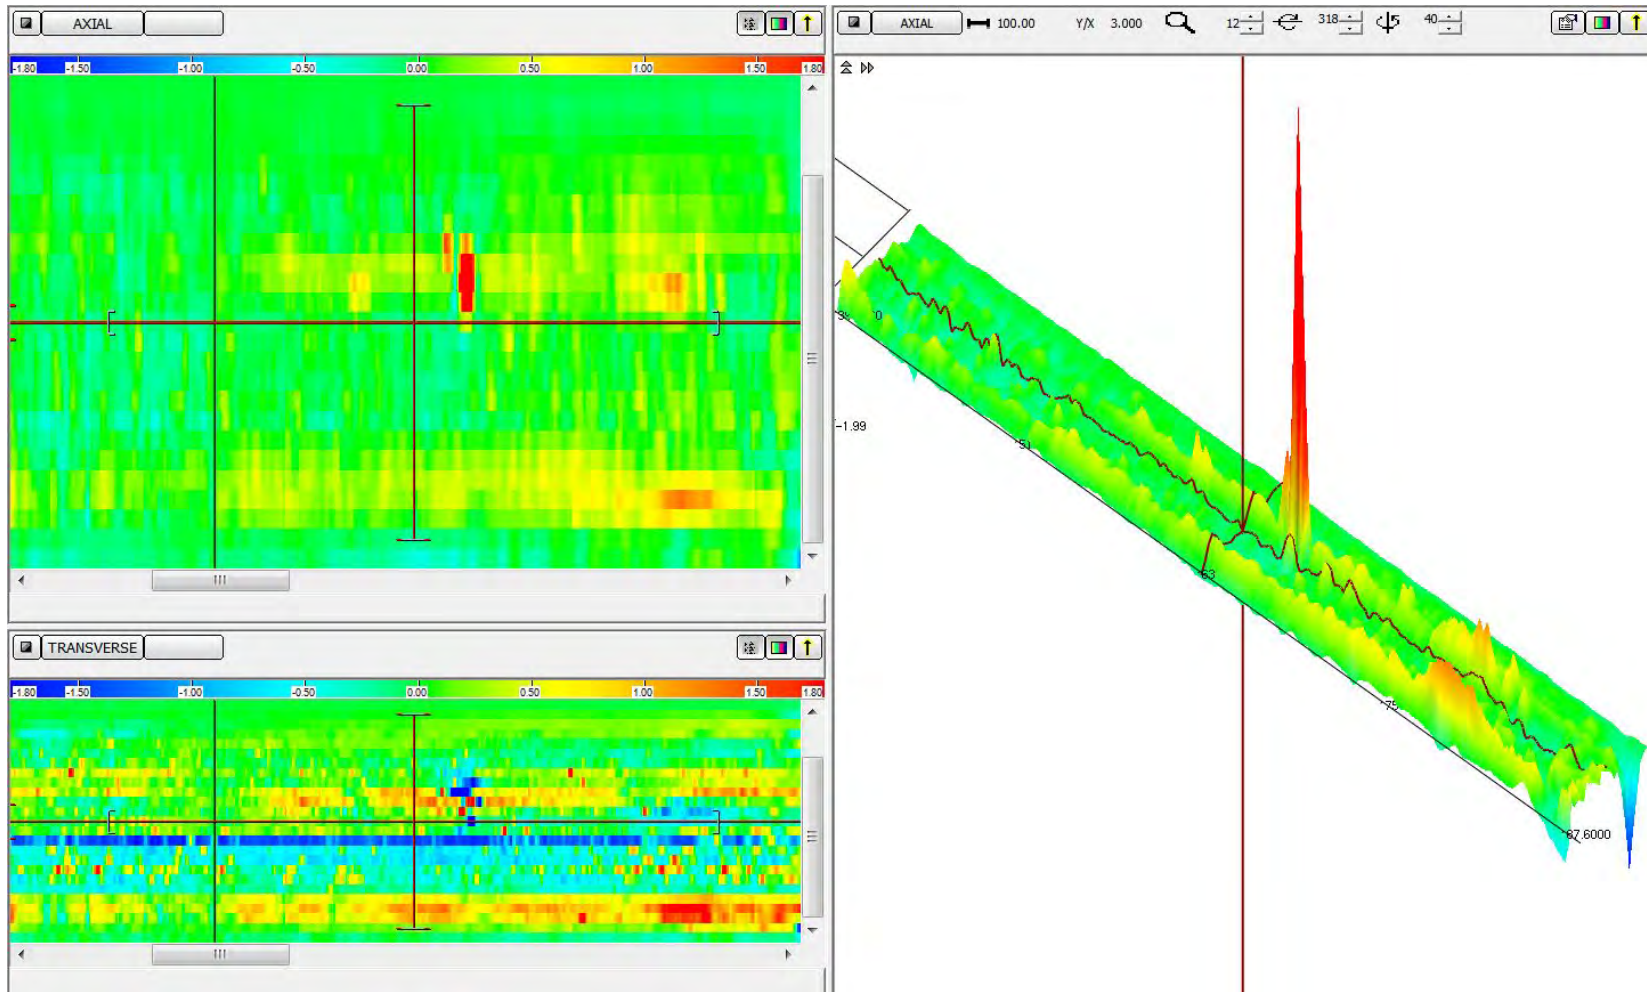
Fatigue pit found on tooth A 98.

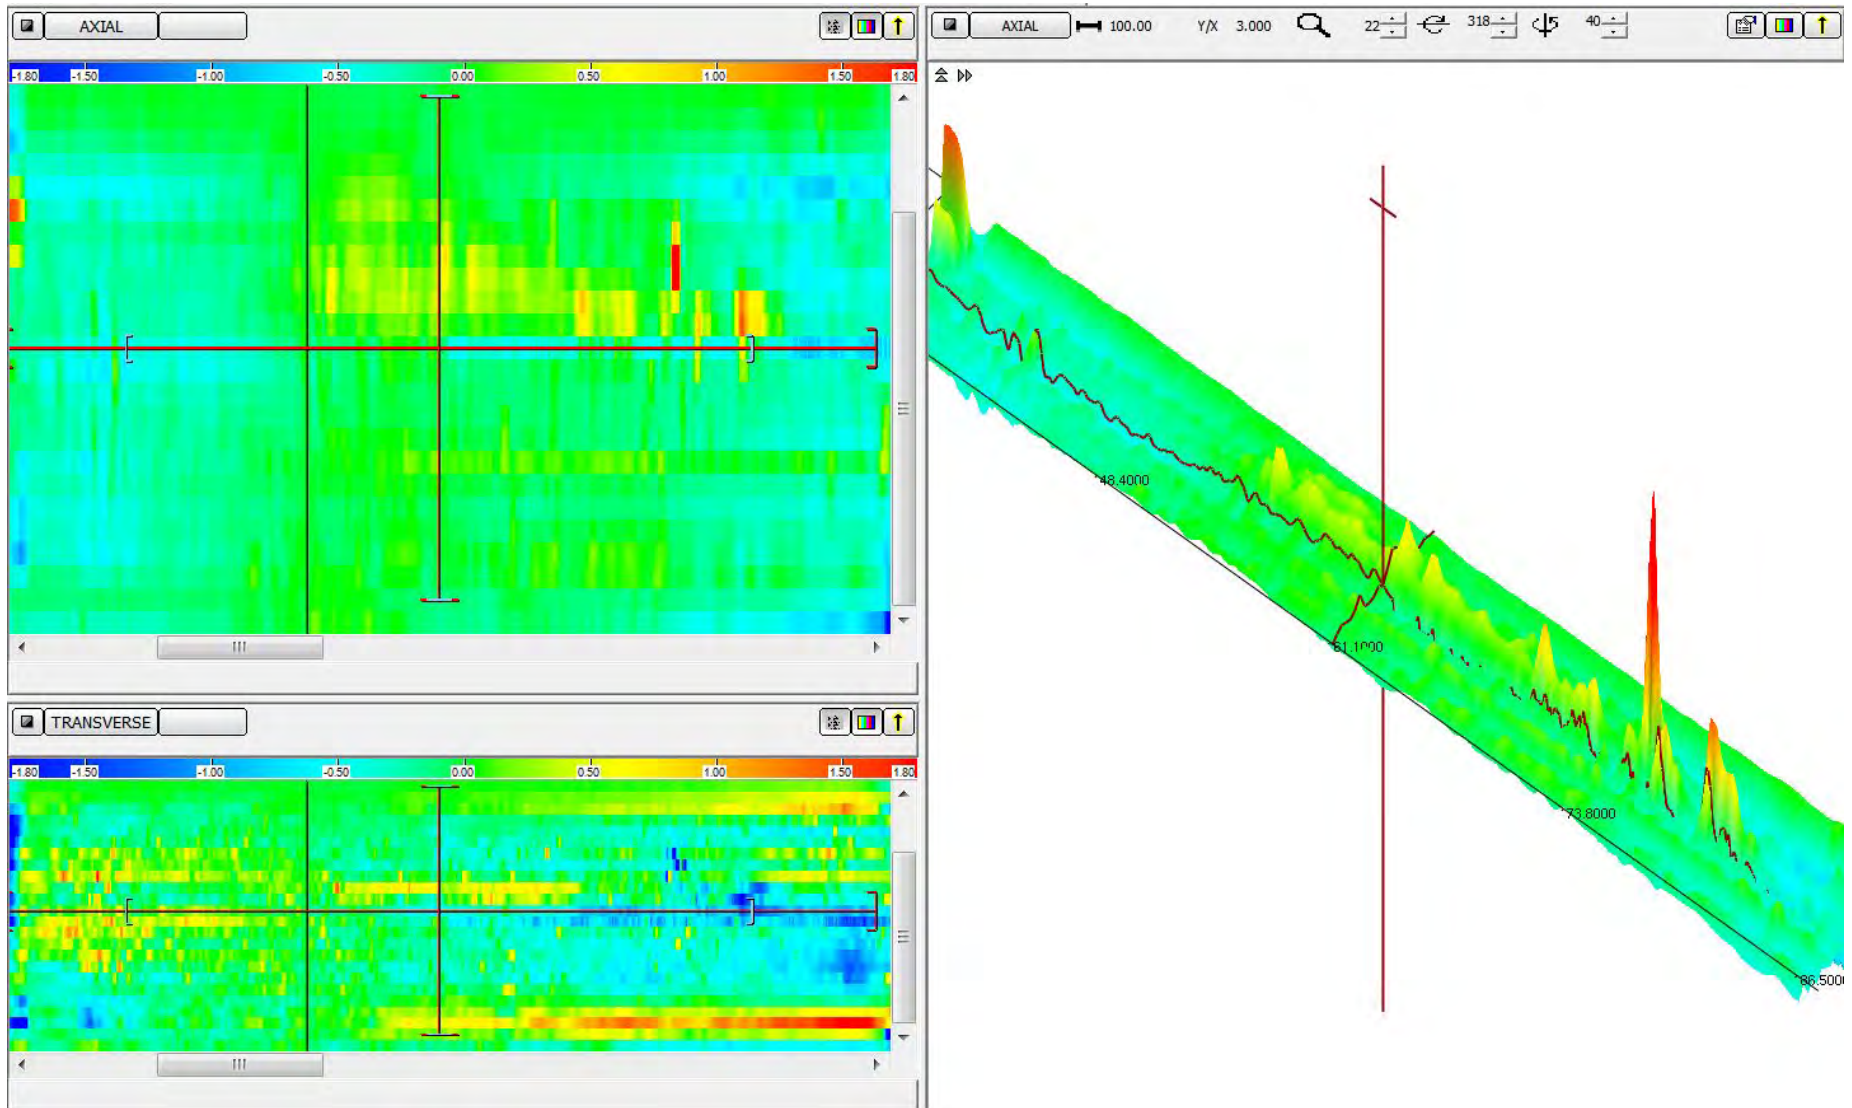
Tooth 223 A - minor surface breaking anomaly apparent

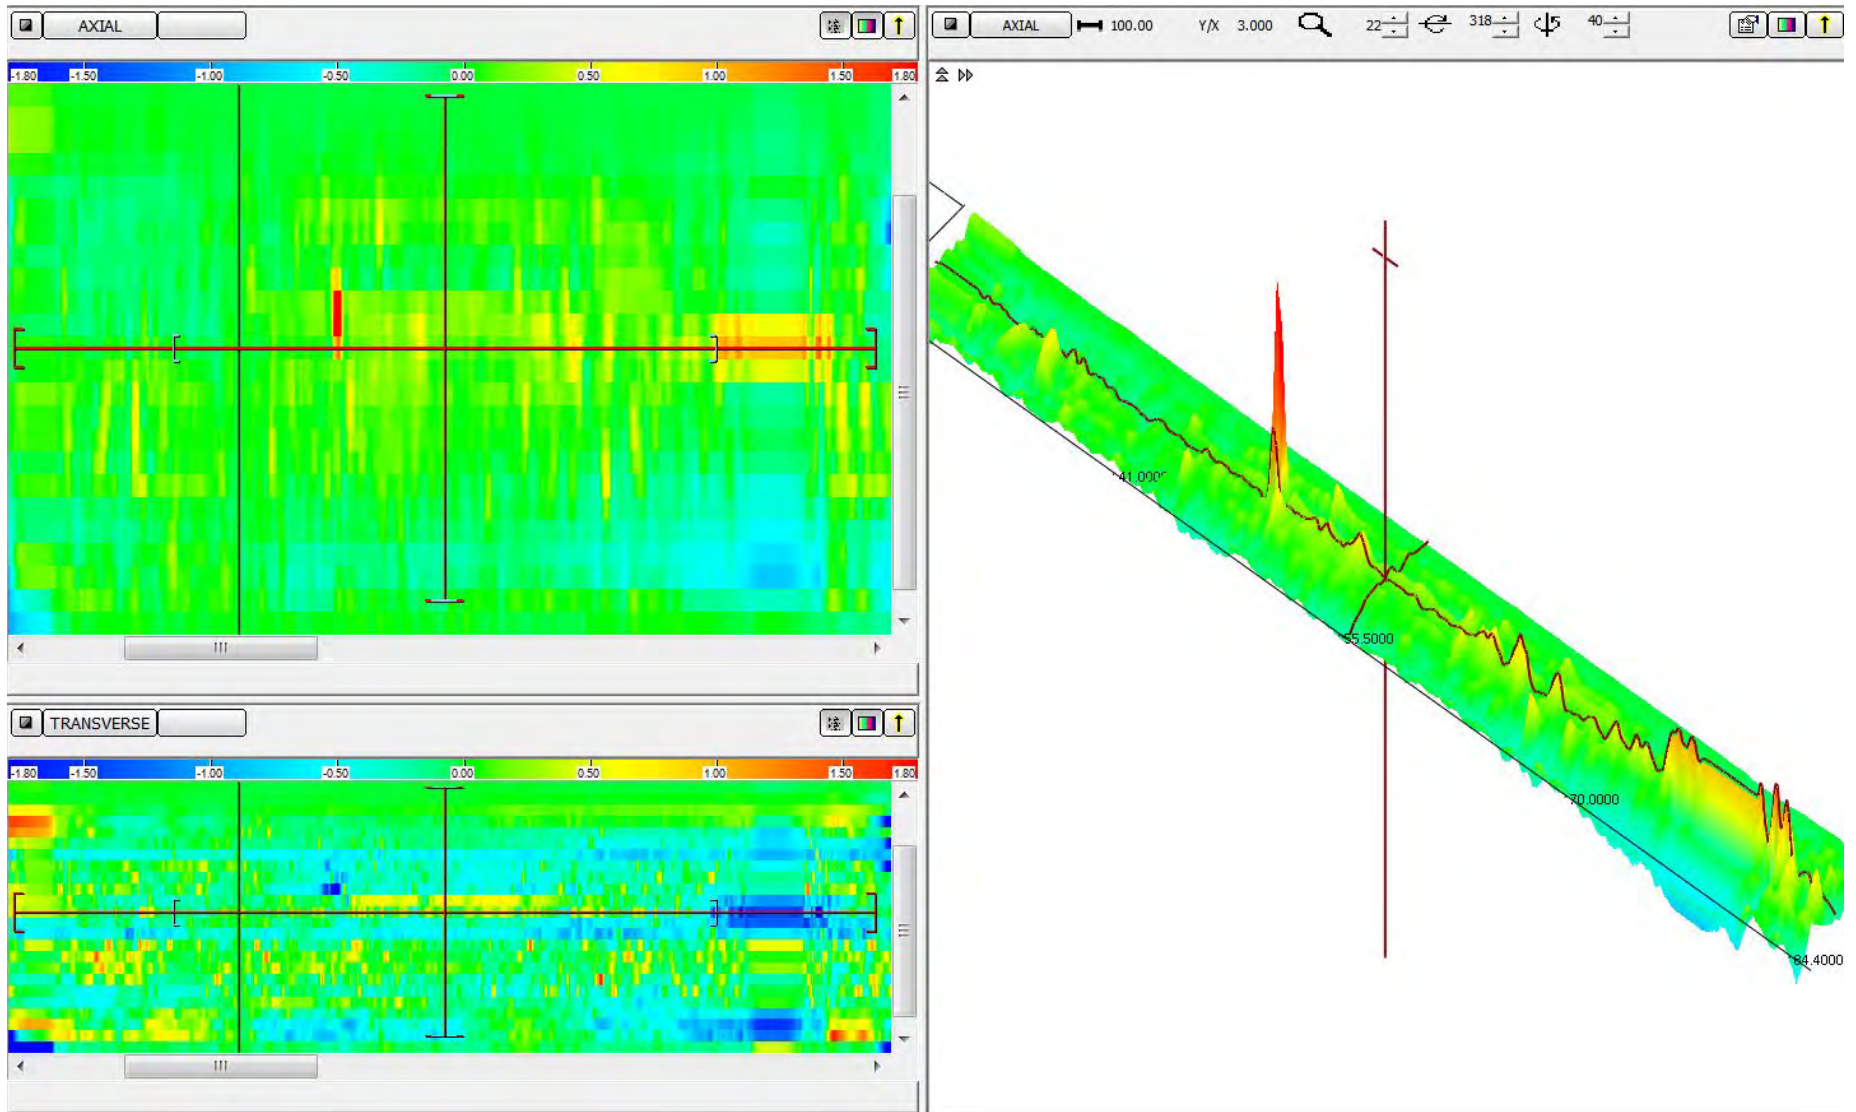
Tooth 253A highlighting the isolated anomaly.

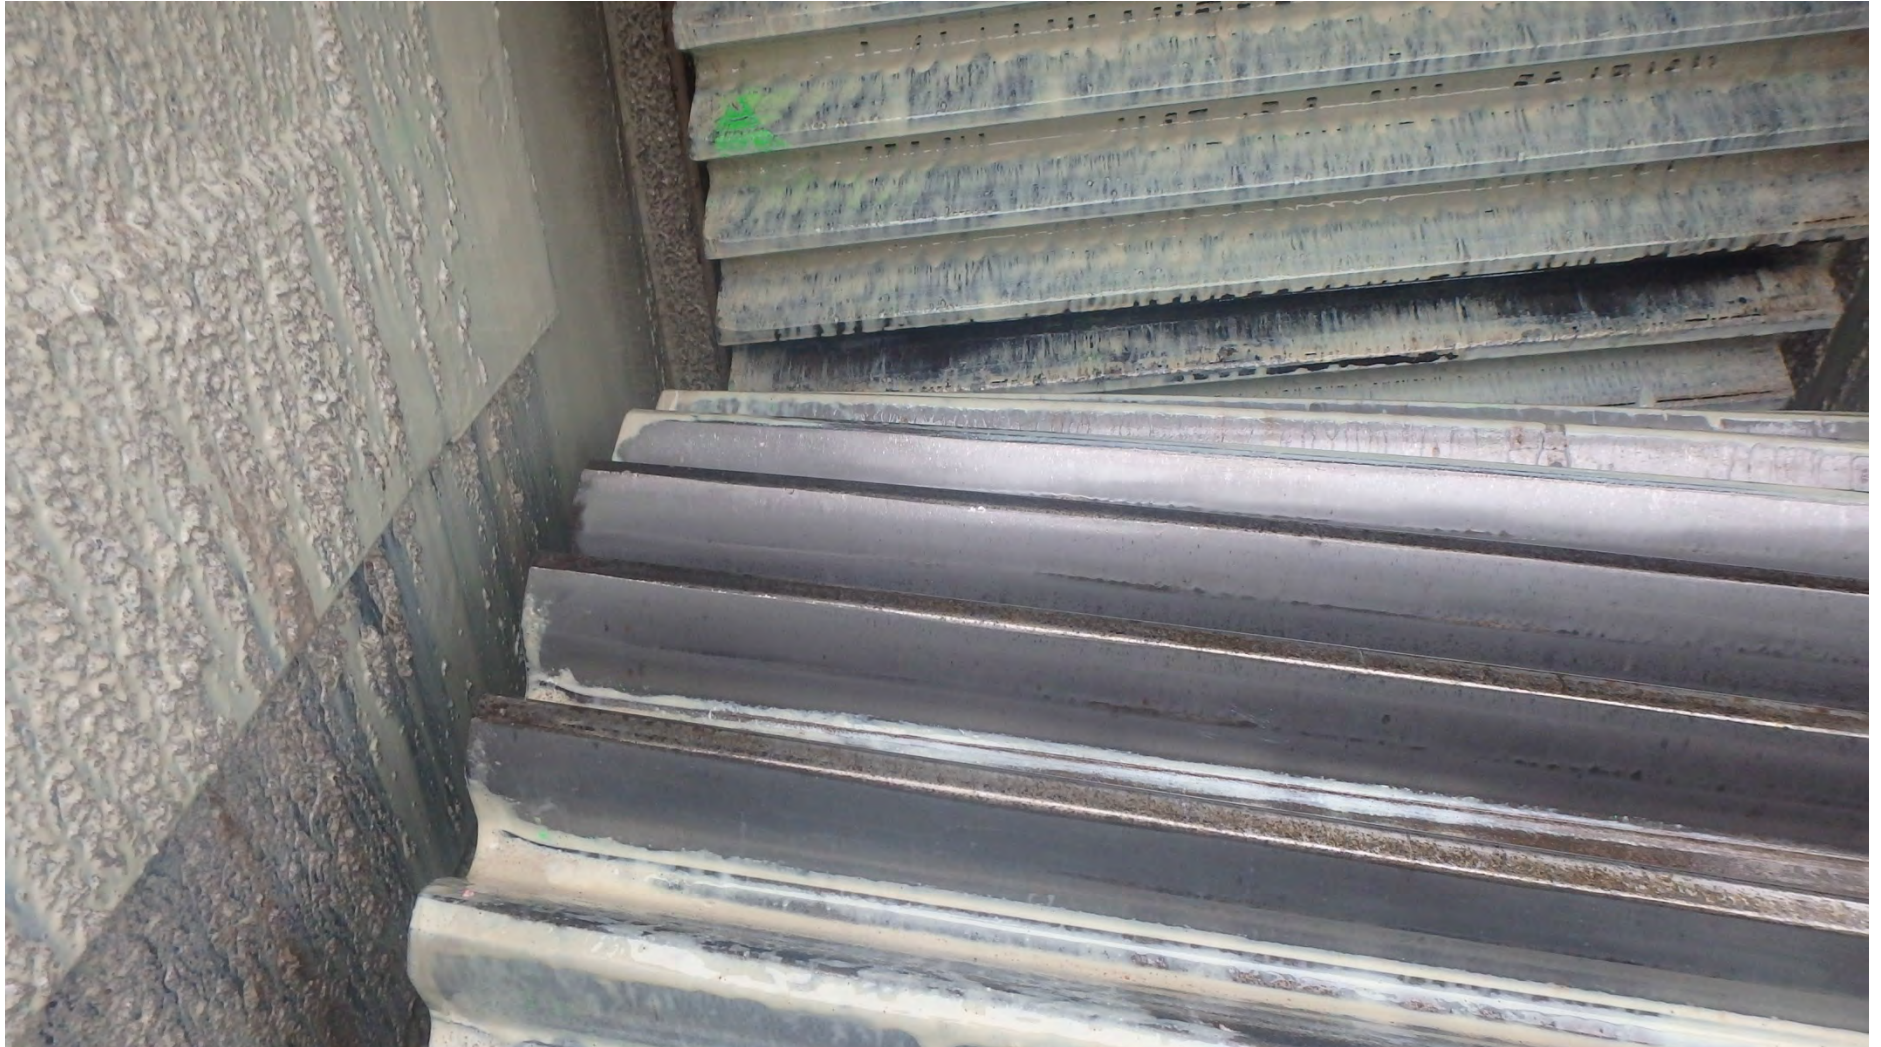
Eddy current array image of tooth 273 A showing an anomaly on the drive end . Due to the position of the mill a decent photograph was not available.

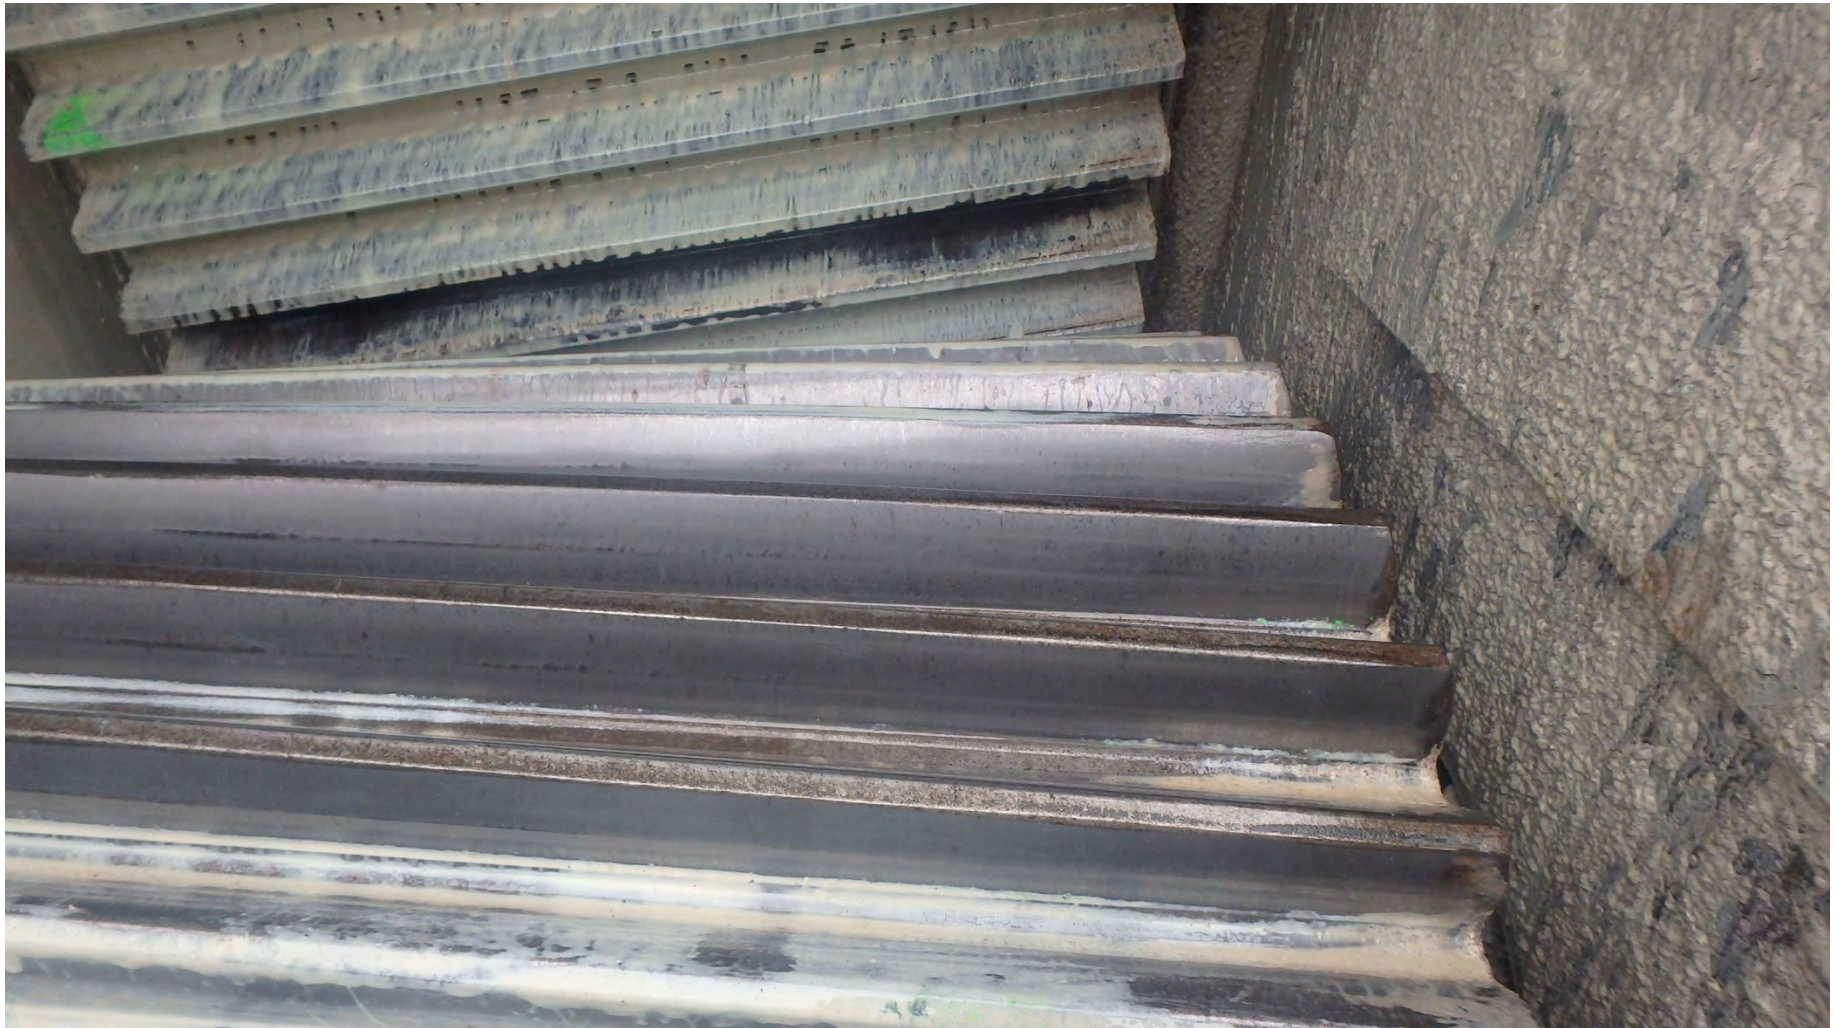
Pinion gear drive end. Note the raised pitch line.
