A GOLDMINE GOLD

A goldmine Gold Mine

Pinion Surface Remediation

Author	Justin Marwick	19/10/2016
Client	A goldmine Gold	A goldmine
Job Date		26 th September 2016
Order Number	Purchase Order No

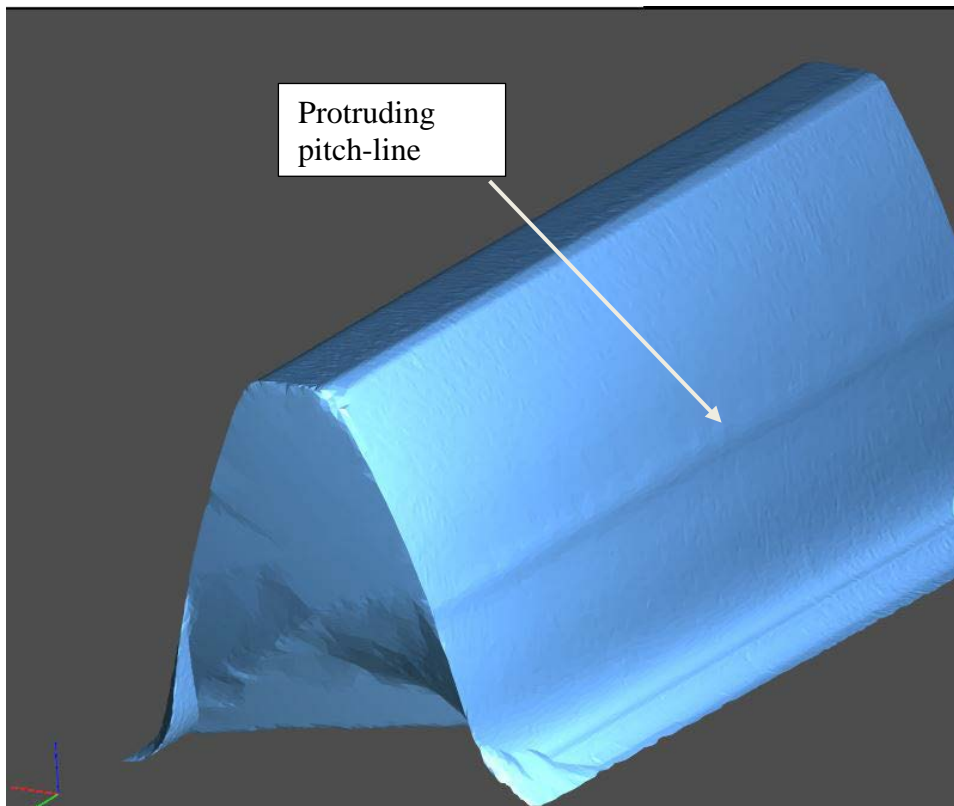
The pinion gear had developed a protruding pitchline area due to contaminant ingress and abrasive attrition of the sliding regions of the pinion and girthgear. As the pinion is the harder of the two gears – the protruding section of the pinion depresses the corresponding area of the girth gear. The localized load concentration can cause enough stress in some cases to result in surface fatigue – specifically spalling.

Fig 1 actual 3-dimensional scan of the A goldmine pinion tooth before intervention

The decision was taken to attempt to even out the load by removal of the protruding area.

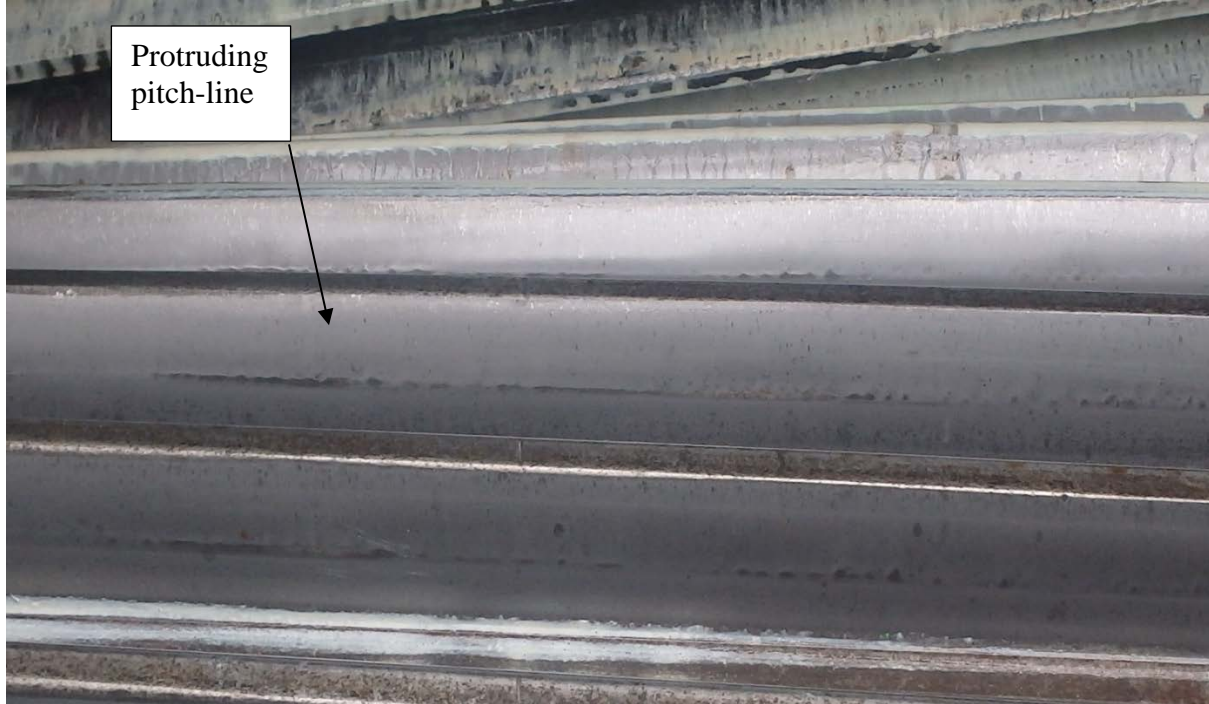
Fig 2 photograph of the pinion before intervention.

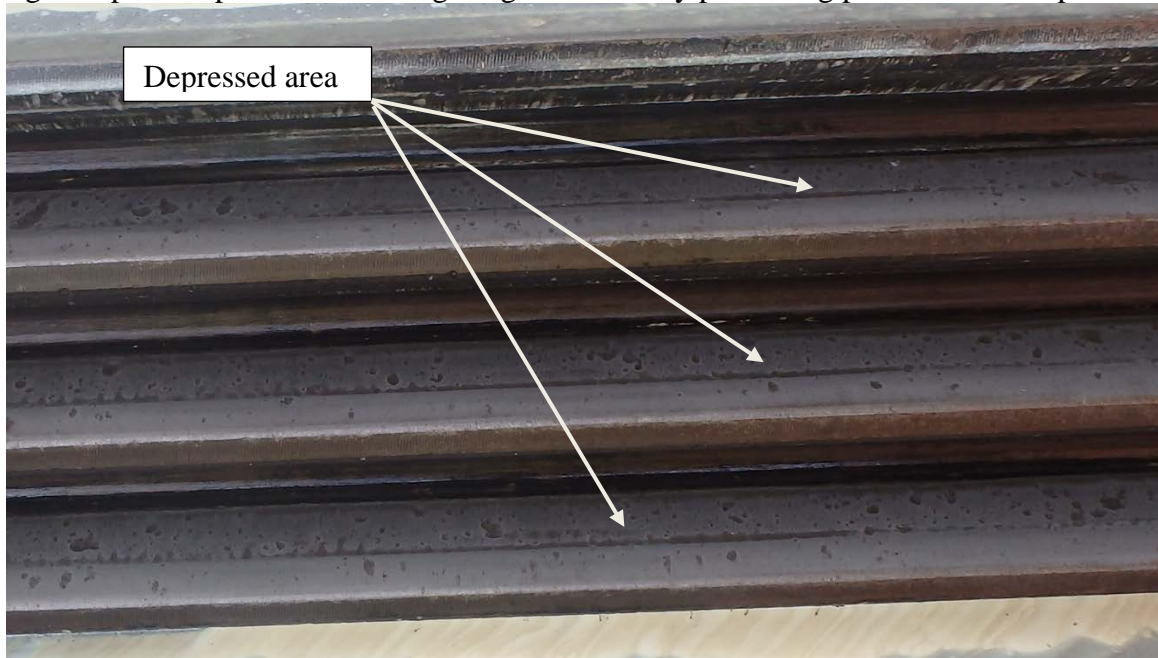
Fig 3 Depressed pitch-line on the girth gear caused by protruding pitch line on the pinion

No remediation was carried out on the girth gear during this outage.

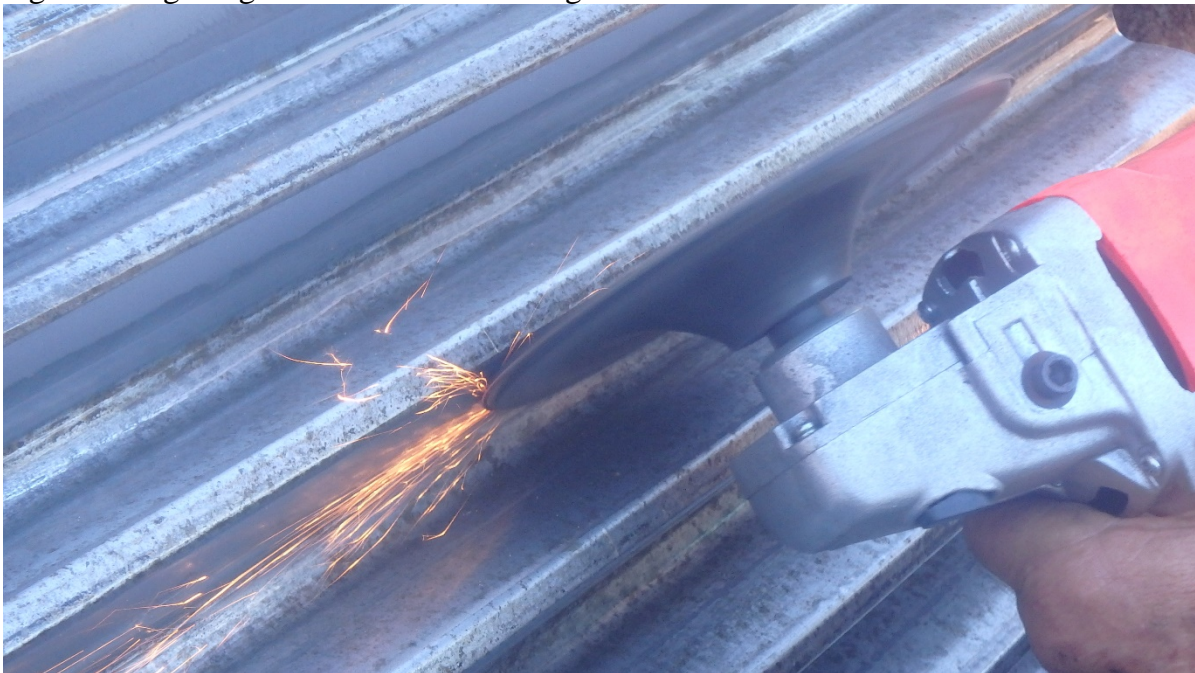
Fig 4 Sanding using a flexible backed sanding disc

The protruding area of each pinion tooth was removed by a 2 step process.

1. Removal of bulk material using a sanding tool with 36 grit paper
2. Smooth the area using an emery oil stone.

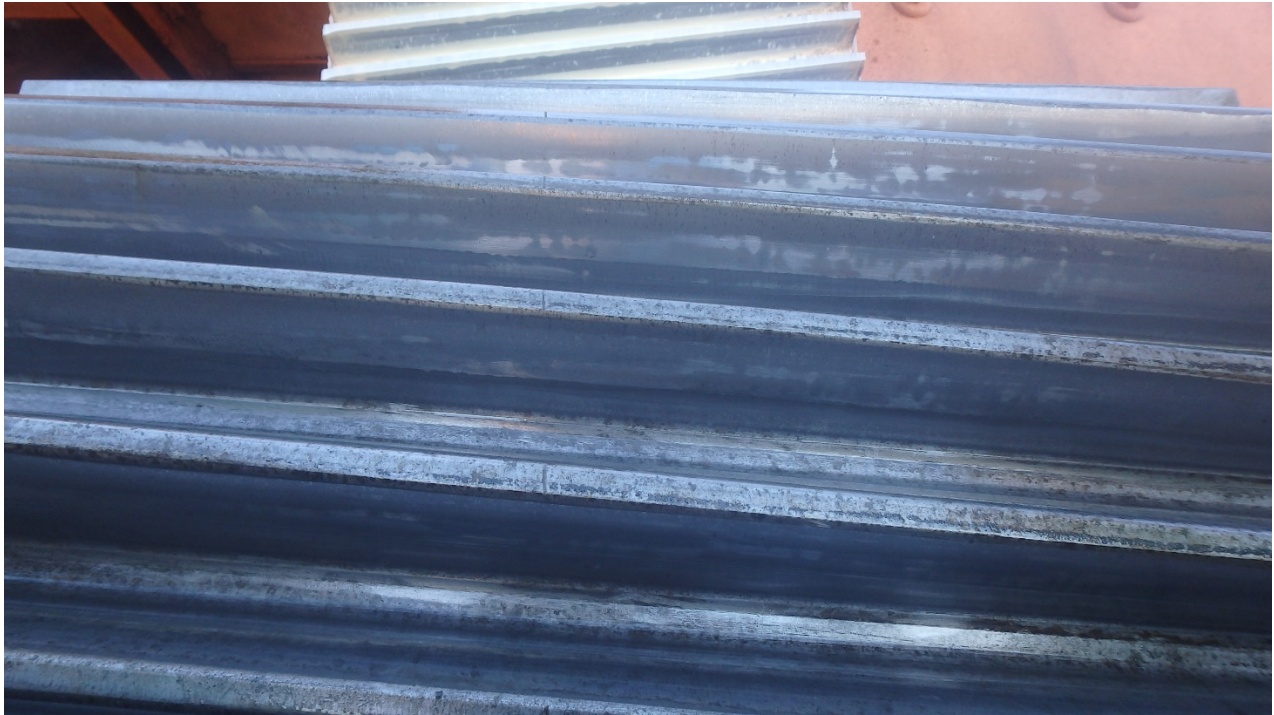
Fig 6 – shiny areas denote areas that stood out from the gear surface before intervention.

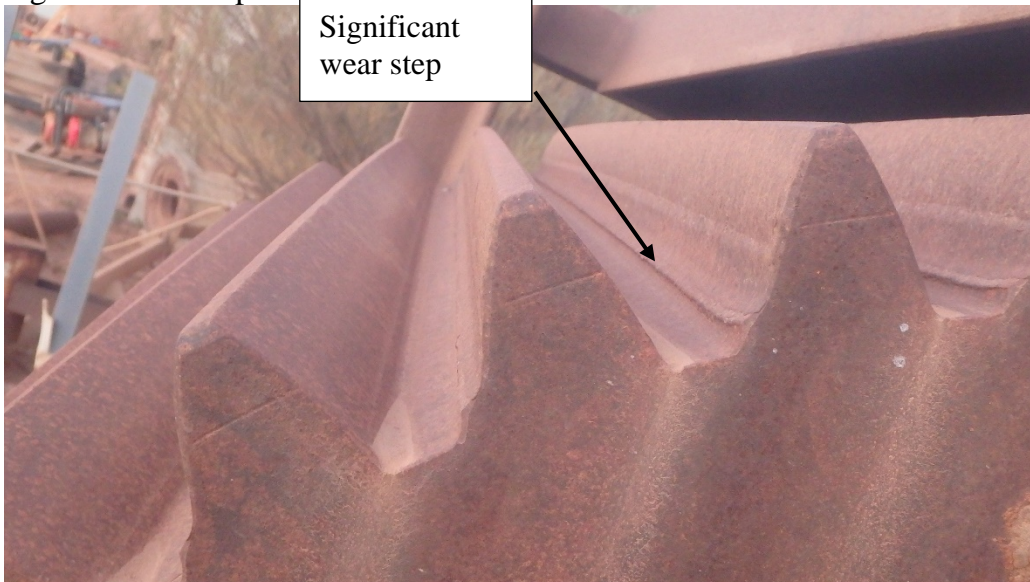
It was noted that there is a used pinion at site. It could be described as poor condition.

Fig 6 Pinion wear profile – the pinion has been used before – more worn on one side

This pinion was obviously taken from service due to being significantly worn on one flank and it was obviously used on the other flank before being taken from service.

1. Get a gear manufacturer or a specialist to measure the gear if the specific design details are not known.
2. Get a quote for the supply of a new pinion.
3. Clean up the existing used pinion; apply heavy duty corrosion inhibitor and store under cover.

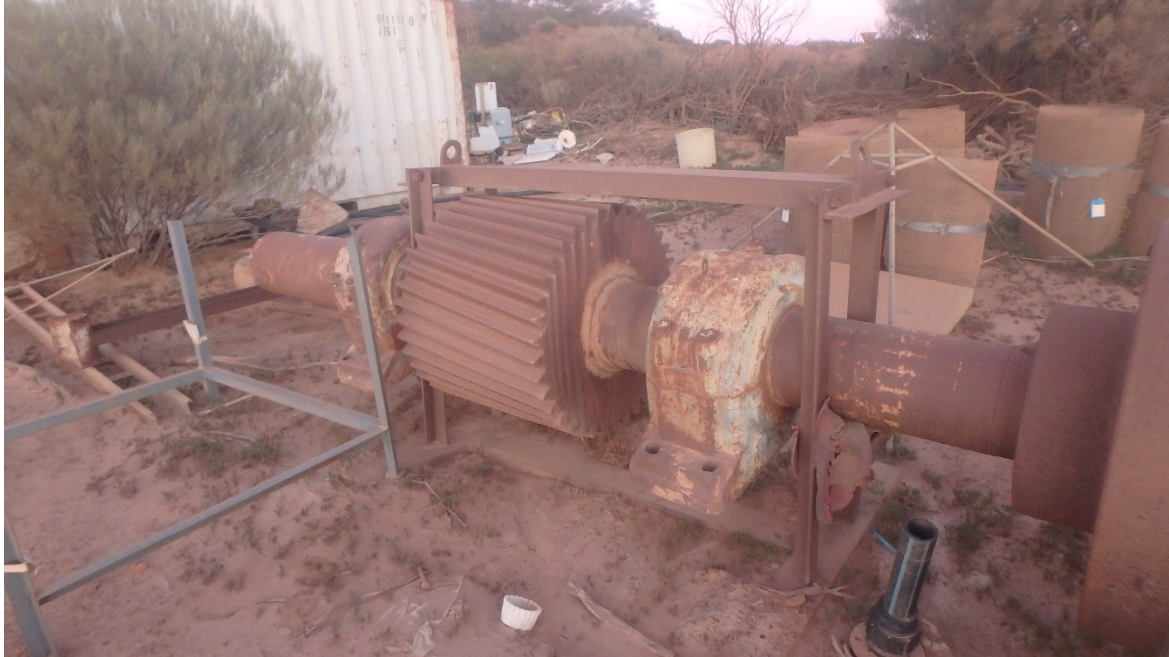
Fig 7 Pinion storage conditions

Use the “spare pinion” shown in Fig 7 to continue operation until a new pinion can be manufactured. The coupling is currently on the correct end of the shaft to make use of the less worn pinion flank.
