A mine Mining LTD

SAG 2 GEAR FAILURE REPORT REVIEW

Date 10th December 2020	Author	Justin Marwick
	Notes and Review

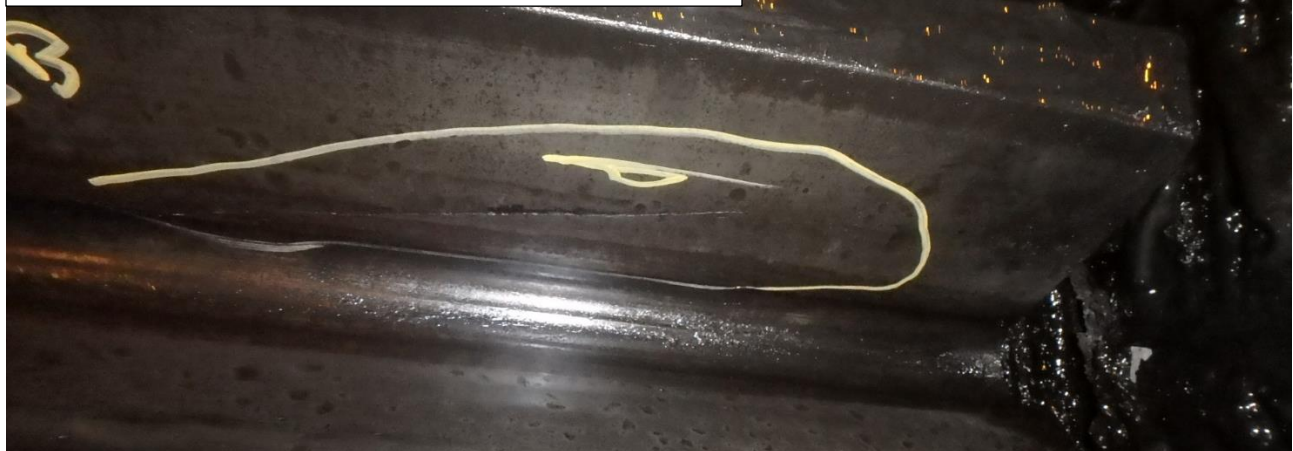
The crack is on the unloaded side of tooth 393 mostly in the root region, however, the most advanced part of the crack was on the unloaded side in the dedendum.

Fig 1 Crack on unloaded side of tooth 393 March 2019

This is highly unusual as the bending stresses in that area are predominantly compressive.

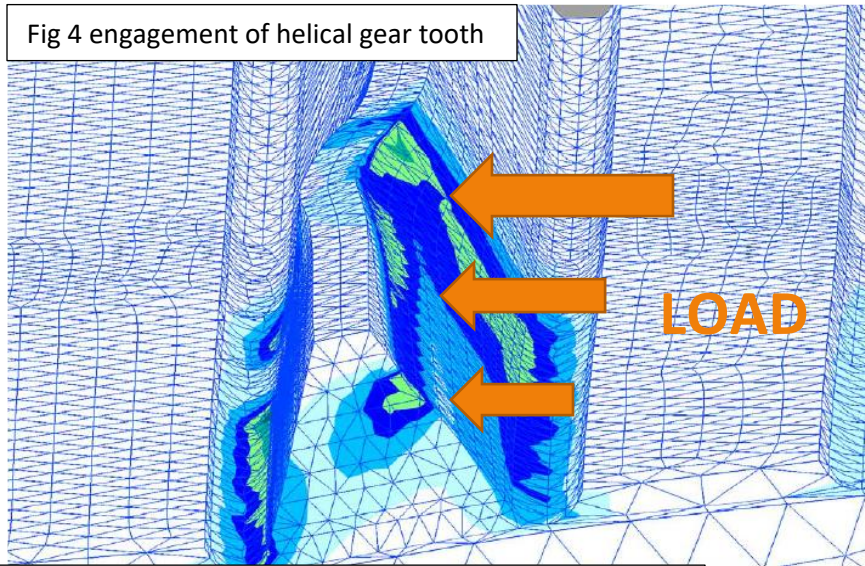
Helical gears have a sliding mode of engagement were as the gear contact progresses along the gear contact surface the gear is flank is deformed resulting in tensile components on the unloaded side.

Fig 4 gives an exaggerated impression of this situation. Given the deformation in Figure 4 the stress condition most likely to initiate a crack on the opposite face would be somewhere just above or in the dedendum – root area in the 1<sup>st</sup> 1/3 from the Drive end.

Fig 4 engagement of helical gear tooth

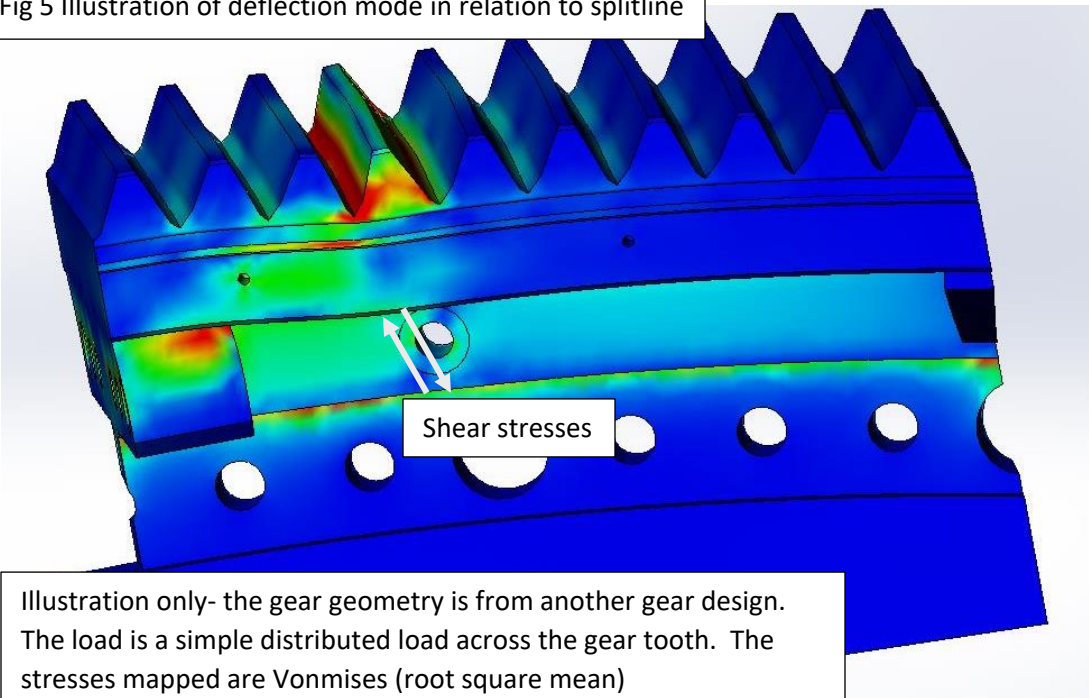
The discussion then roles onto some speculative statement around – presumably split-line bolts being loose. I am not aware of any failures that the author describes. It would be very obvious if one of the mounting bolts or one of the splitline bolts were behaving as the author describes. On a helical gear such as this the contact ratio is seldom more than 2 talk of 4 teeth in contact is a little confused. Finally the engagement of the gear teeth and the rotation of the mill means that the tooth 393 is engaged

before teeth 394, 395 and 396 so speculation about loose splitline or mounting bolts is not based on the physics of the situation.

Fig 5 Illustration of deflection mode in relation to splitline

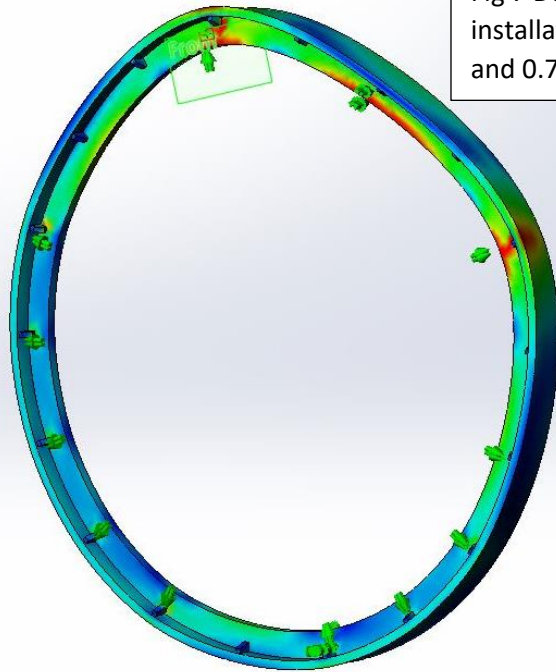
Fig 7 Deformation of a gear due to installation. 0.6, 0.5 and 0.5 mm radially and 0.7 mm axially

As can be seen in Figs 7 and 8 – small displacements can lead to a significant residual stress which can exacerbate pre-existing internal stresses.

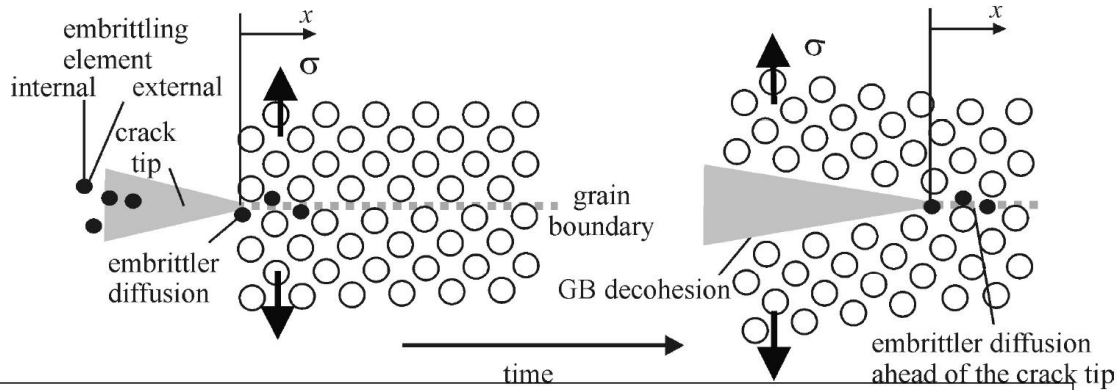
that paper. In addition to the comments in Laczko’s report, I would also suggest that in the regions of significant weld energy (mounting flange to gear rim, stiffener gussets and the splitline hardware, there are the elements contained for dynamic embrittlement. Attached is a paper on this phenomenon.

Fig 9 from Dynamic Embrittlement- Induced Intergranular Cracking By Ulrich Krupp

Dynamic embrittlement is usually associated with elevated temperatures, however as with Hydrogen embrittlement in cast ingots the embrittling agents such as Sulphur and hydrogen are present in the heat effected zone of the welded areas. Mechanical stress mobilizes the embrittling agents and inter granular cleavage starts to occur.
