Goldmine

Author	Justin Marwick	
Review and notes	Brendan Wicks	11/10/2013
Client	Goldmine	Gold Company
Repair date	Ball Mill

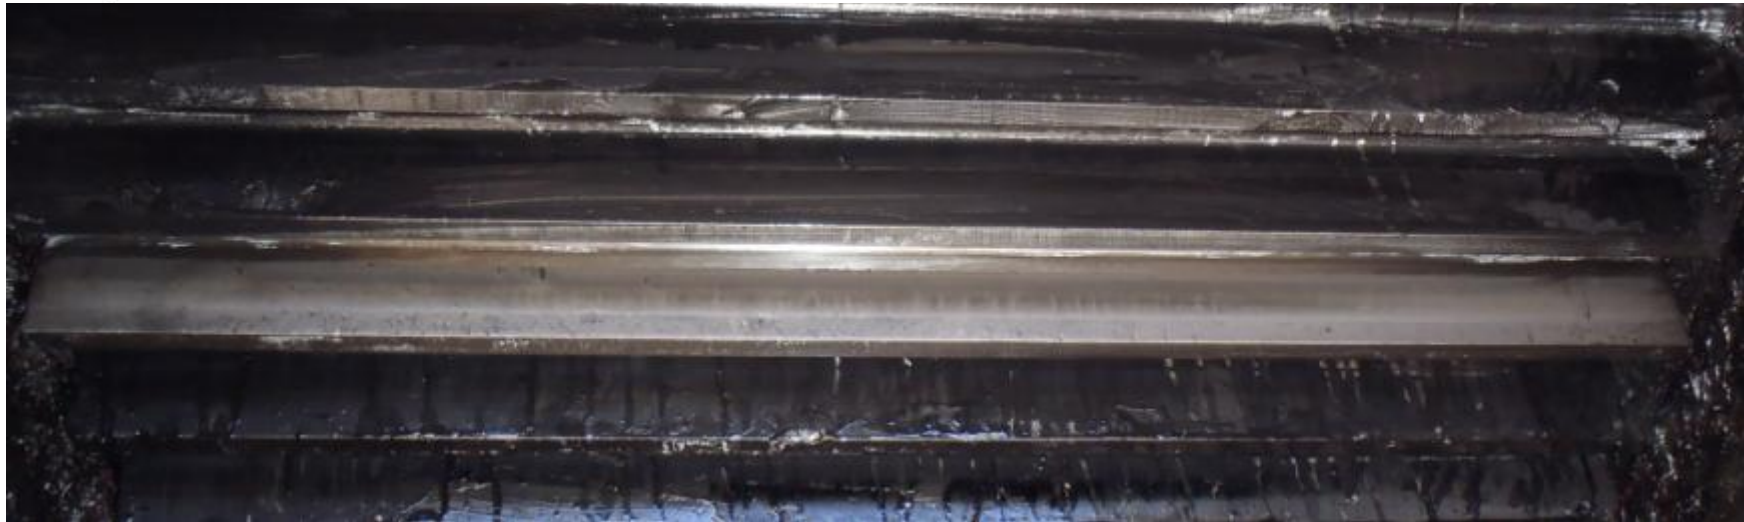
Fig 1 General view of load side tooth 10

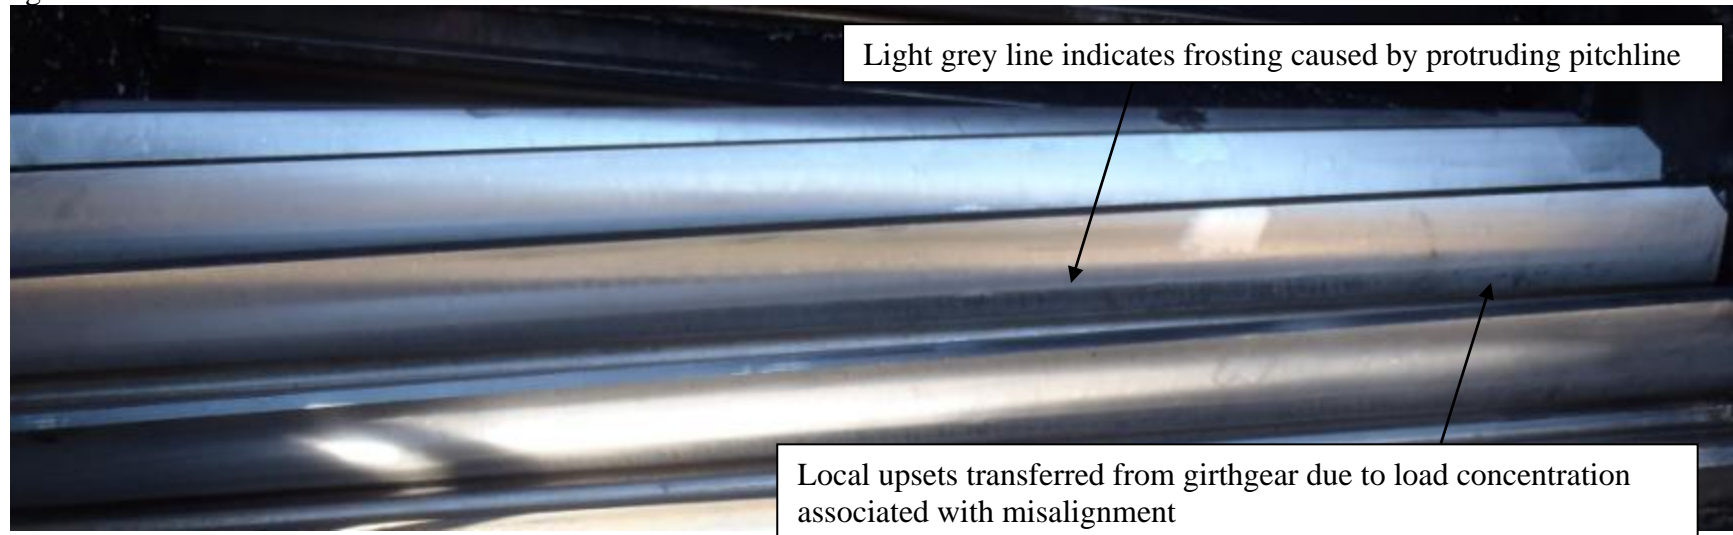
Fig 2 General view of pinion

Both the pinion and girth gear had protruding pitch lines. In the case of the pinion the elevated pitch line was removed using a die grinder and 80 grit flap wheel. In the case of the girth gear a 7” pneumatic sander and 36 grit abrasive paper discs. Results of the excavations and finishing can be seen in section 6 Jobsite photos and Scans

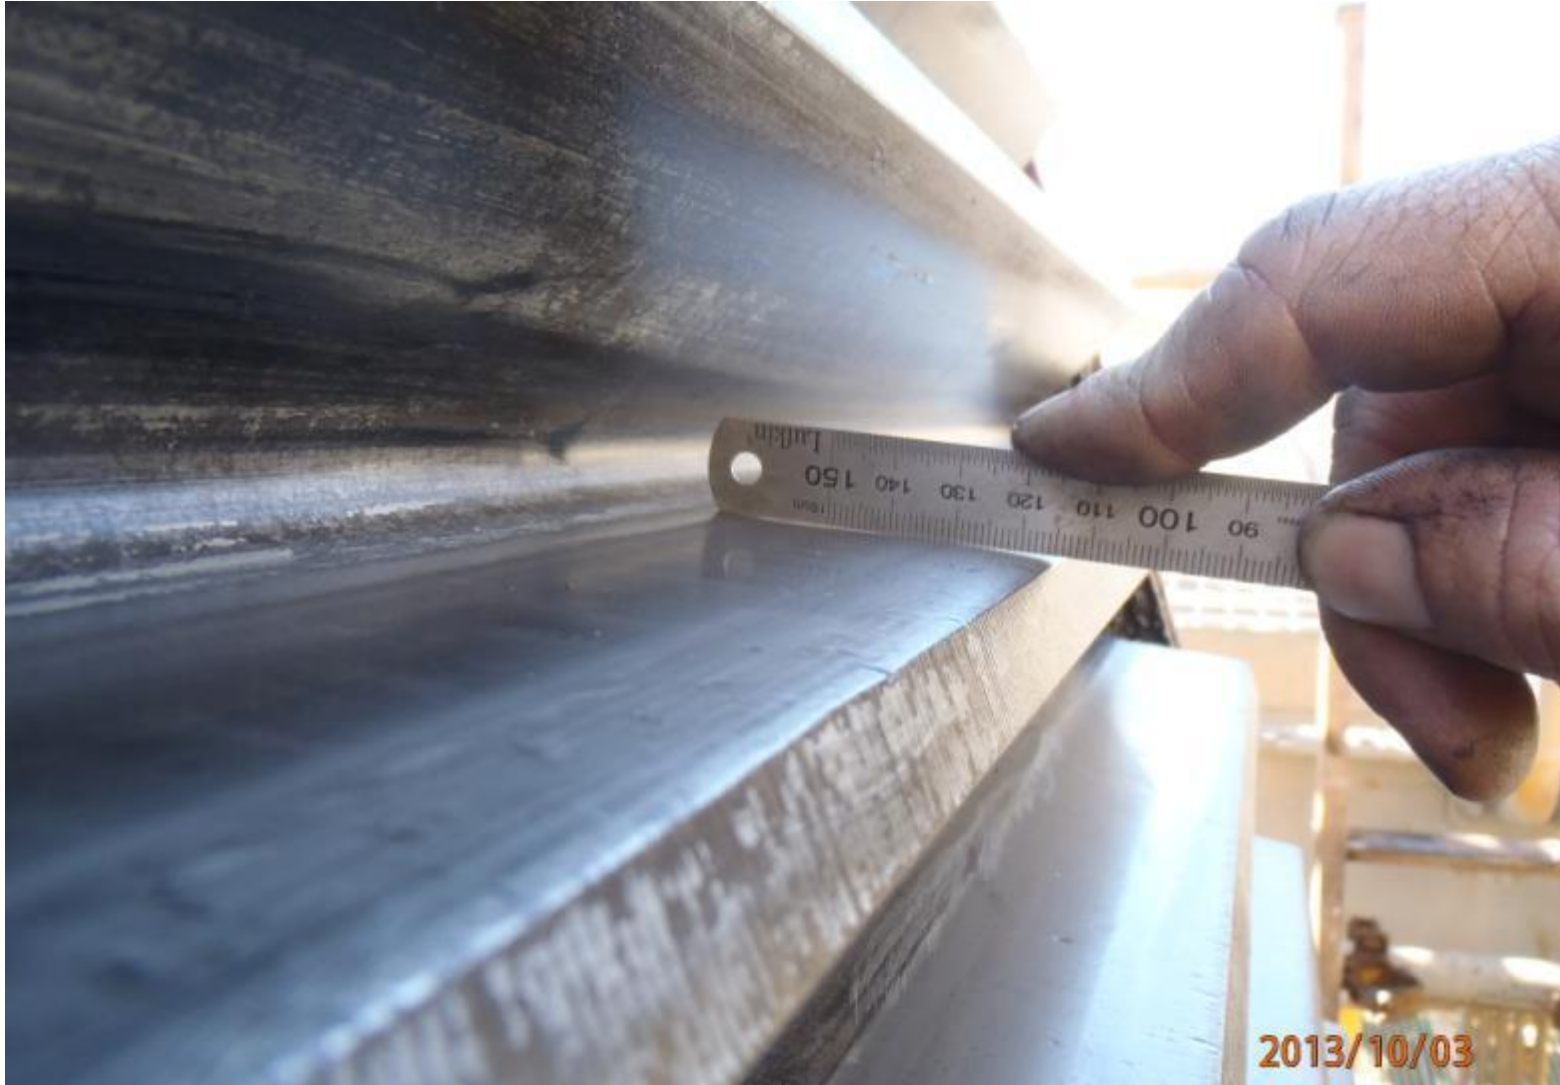
Fig 3 Tooth profile before finishing

The gear flanks and pinion were hand finished to reduce local protruding geometries that cause local load concentrations which in turn can lead to surface fatigue.

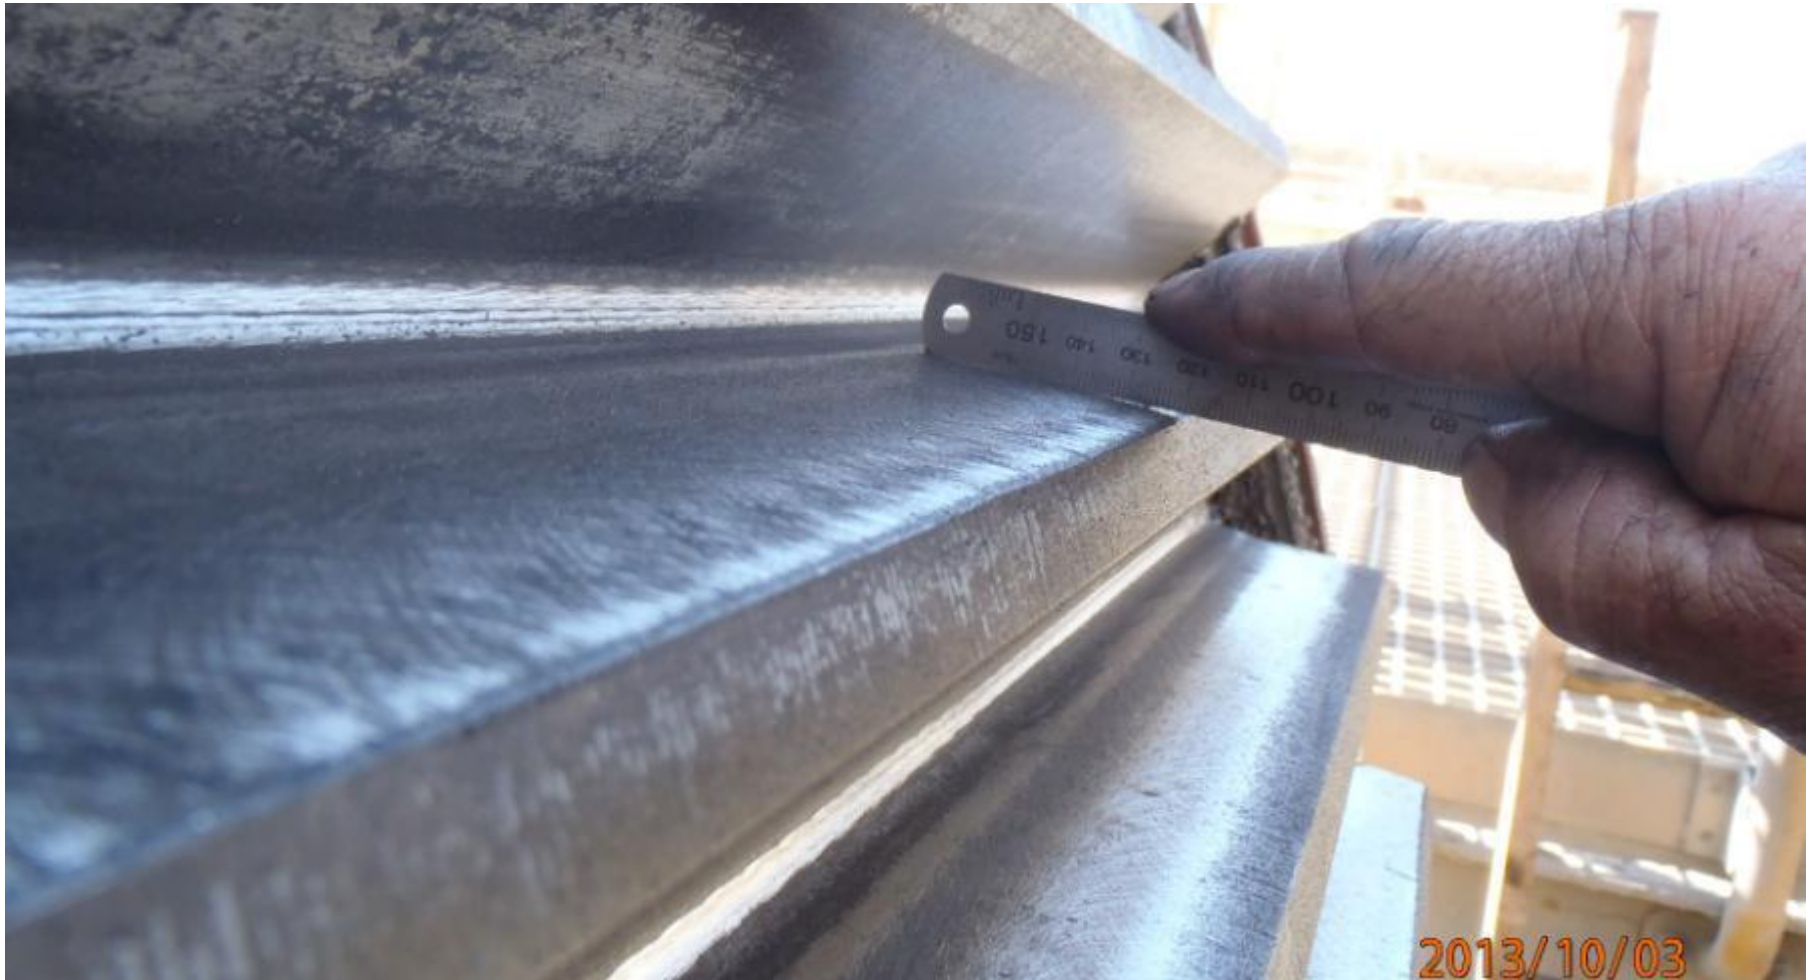
Fig 4: Tooth profile after finishing

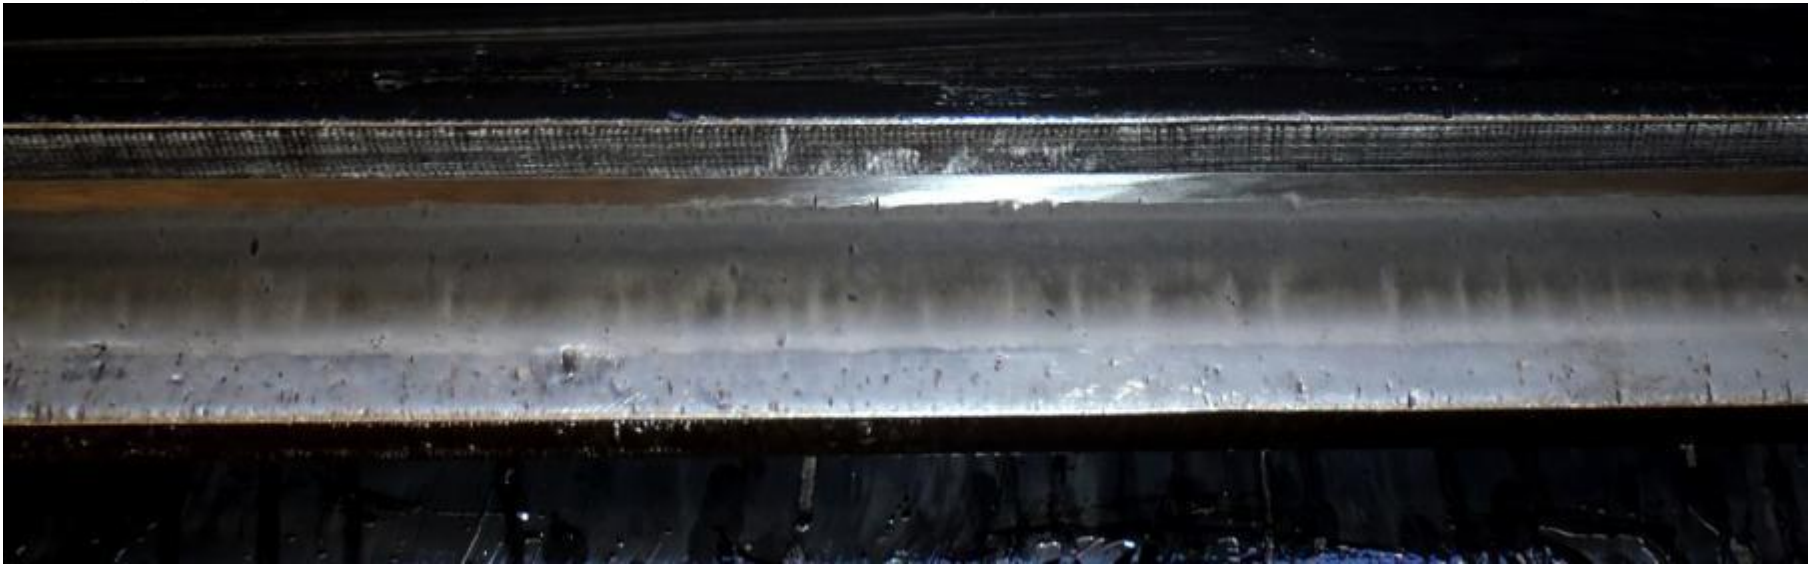
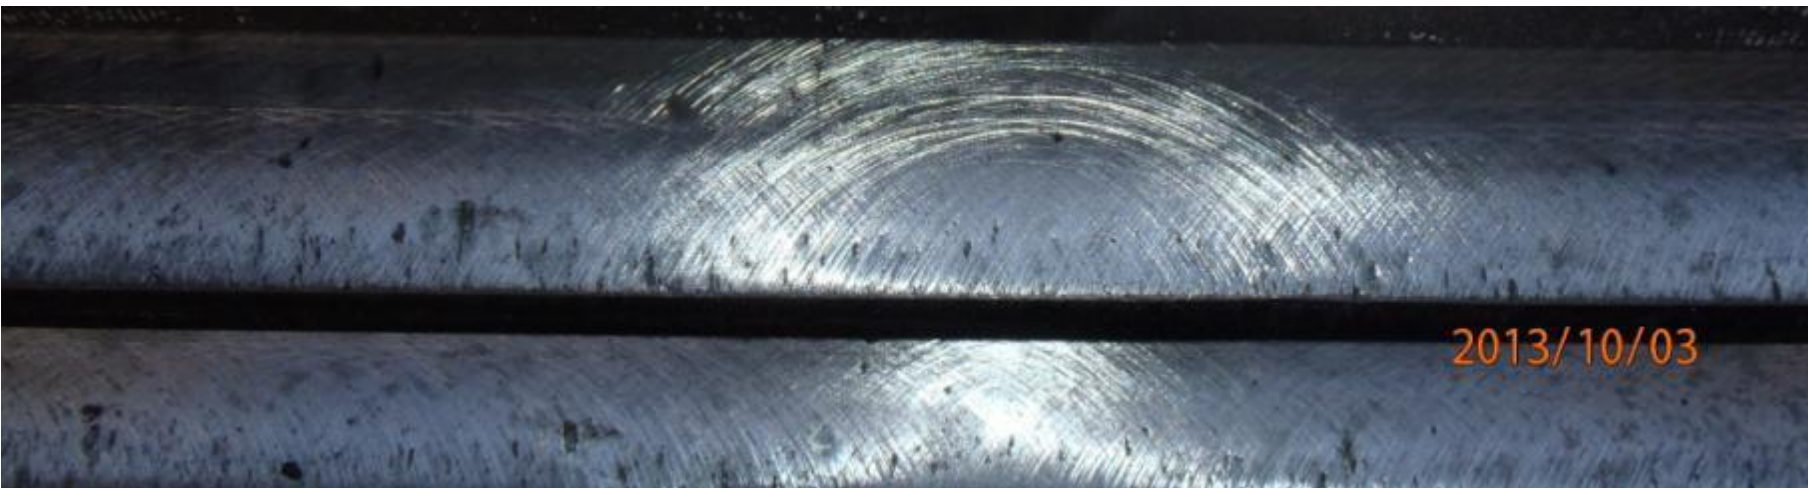
Fig 5(Above): Gear tooth centre before finishing Frig 5B (Below) Gear tooth centre after finishing note the continuous finish marks indicating removal of local protrusions

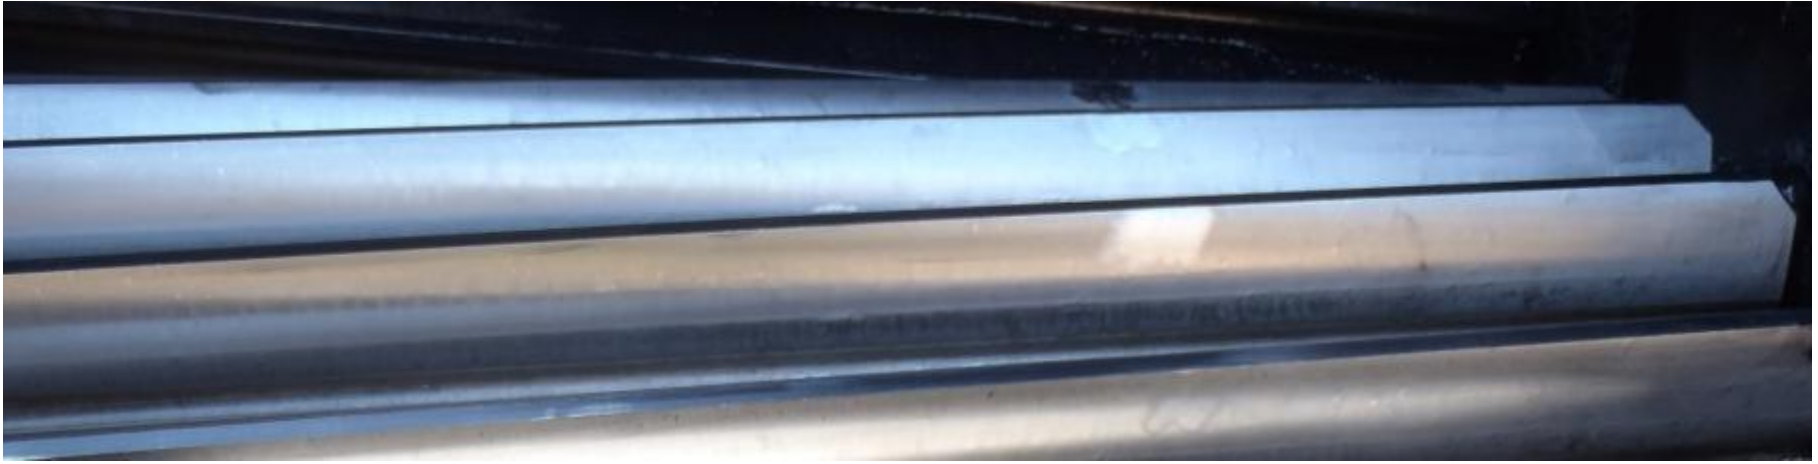
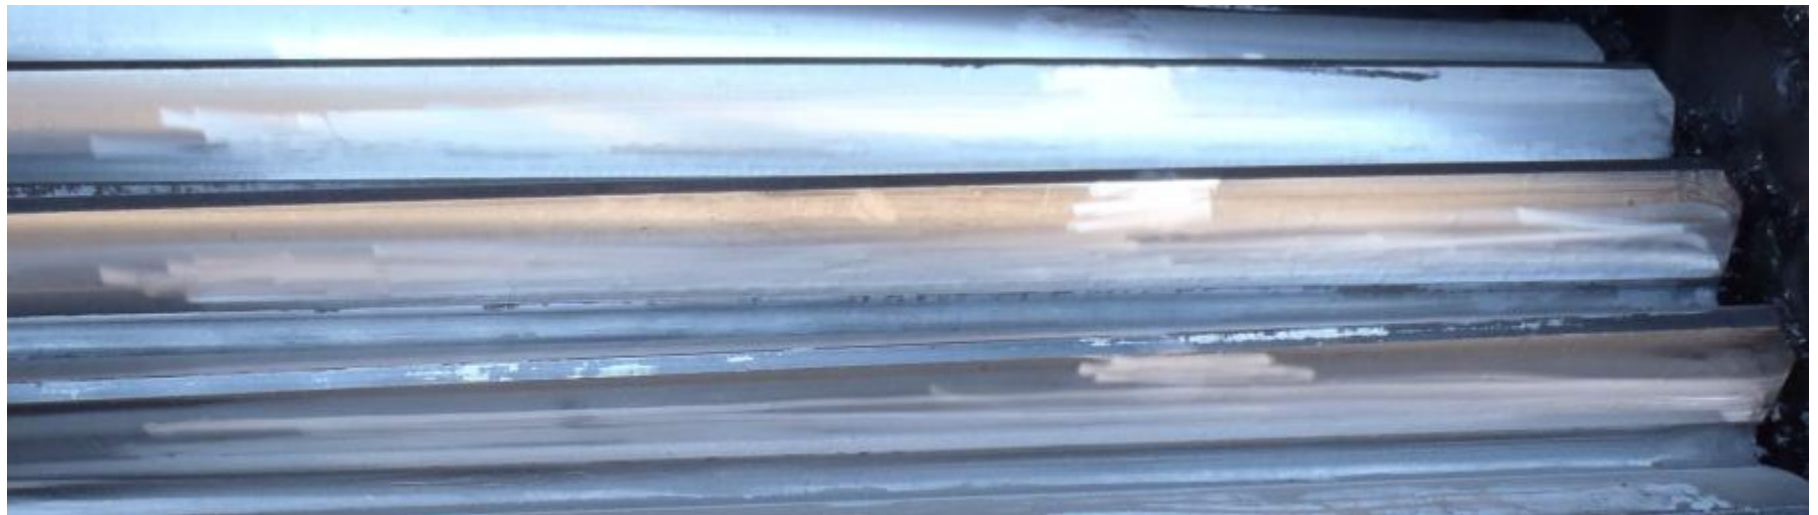
Fig 6a (above) Pinion prior to finishing Fig 6b (below) Pinion after finishing

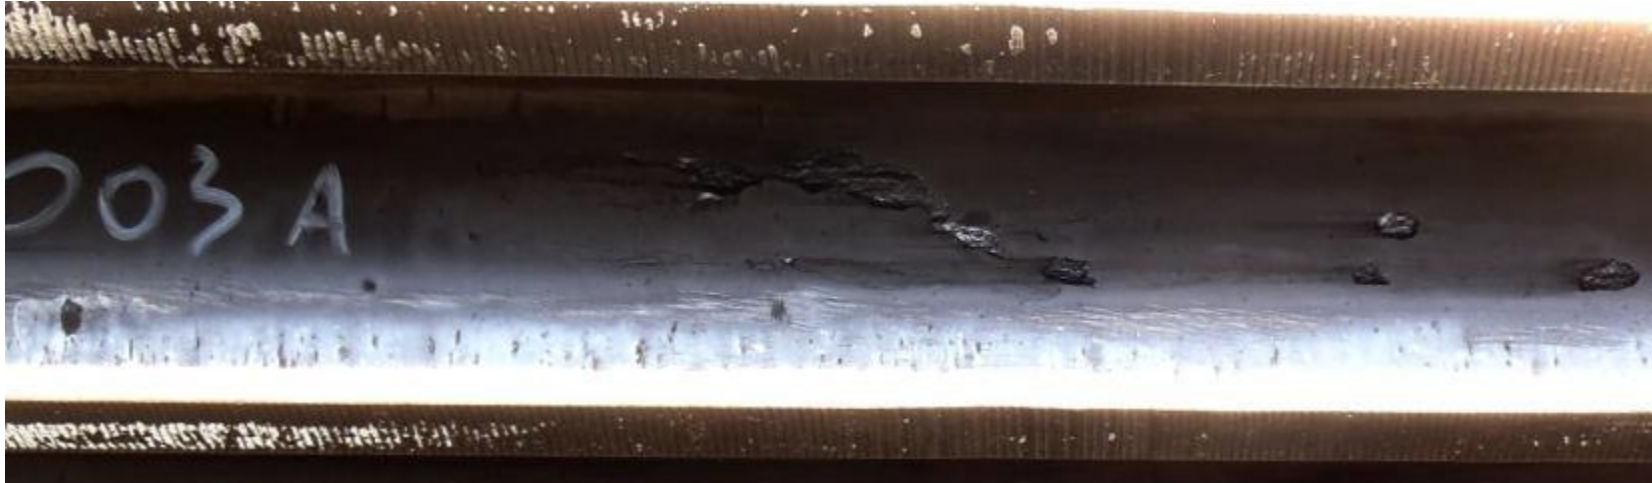
Tooth 003A (load side of tooth number 3) has experienced noticeable deterioration where some localised spalling has expanded and evidence of fatigue over the local region was evident. Tooth 260 A had also deteriorated where additional fatigue spalls had fallen from the gear surface. Both of these gear teeth have been remediated by profiling the fatigued material and polishing the excavated surface to prevent crack re-initiation.

Fig 7 Tooth 003A Oct 2013 surface showing obvious fatigue and exfoliation

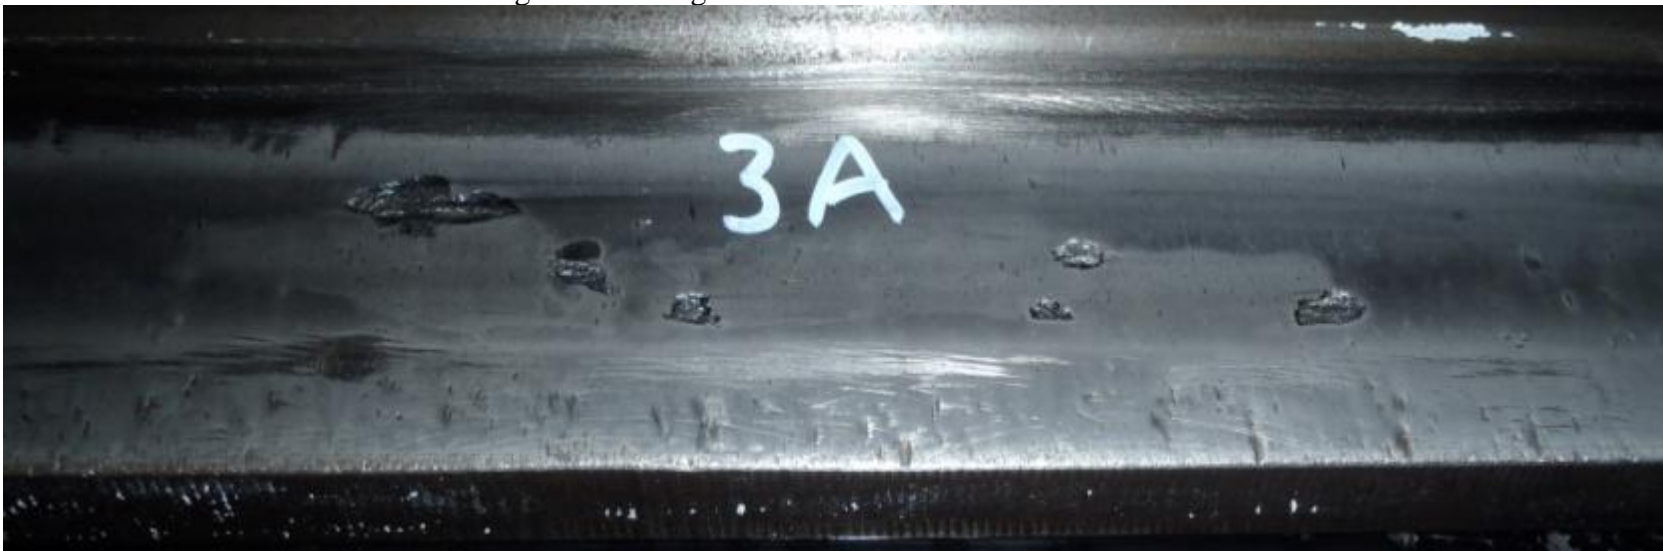
Fig 8 Tooth 003A 2011

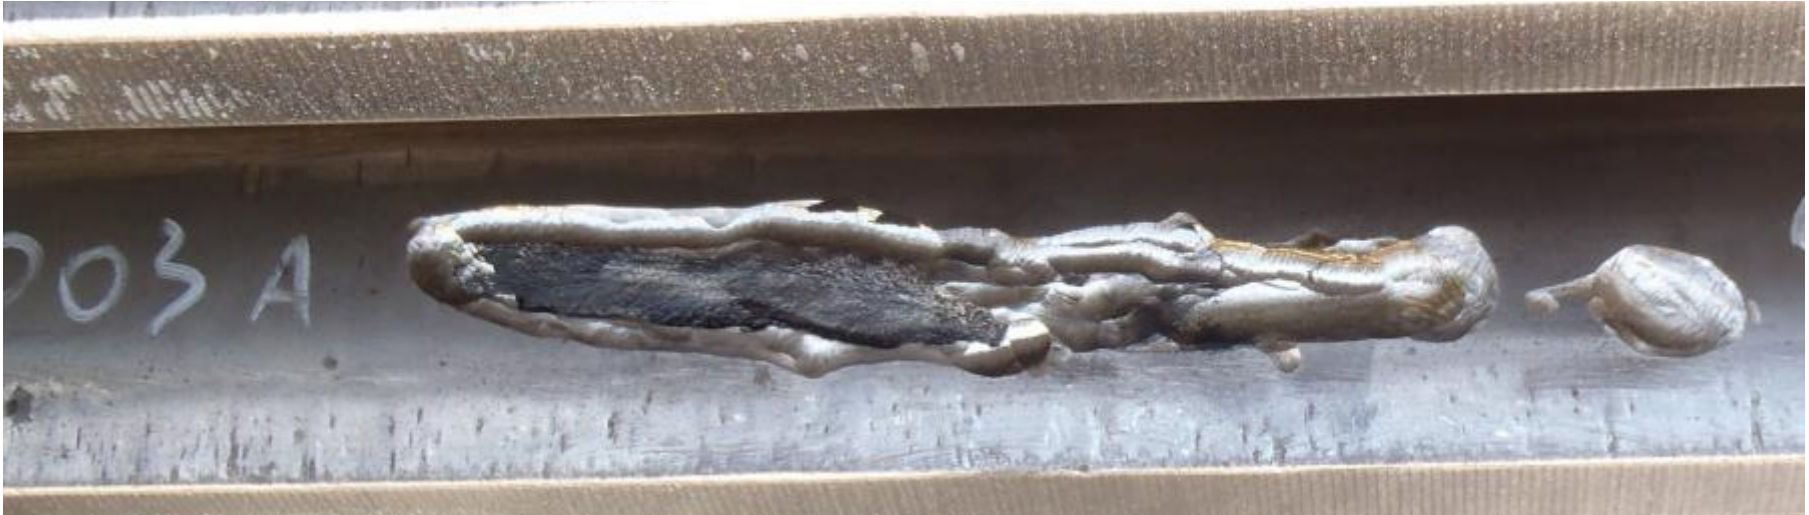
Fig 9 first stage of excavation – a chunk had cracked under the surface (dark grey area)

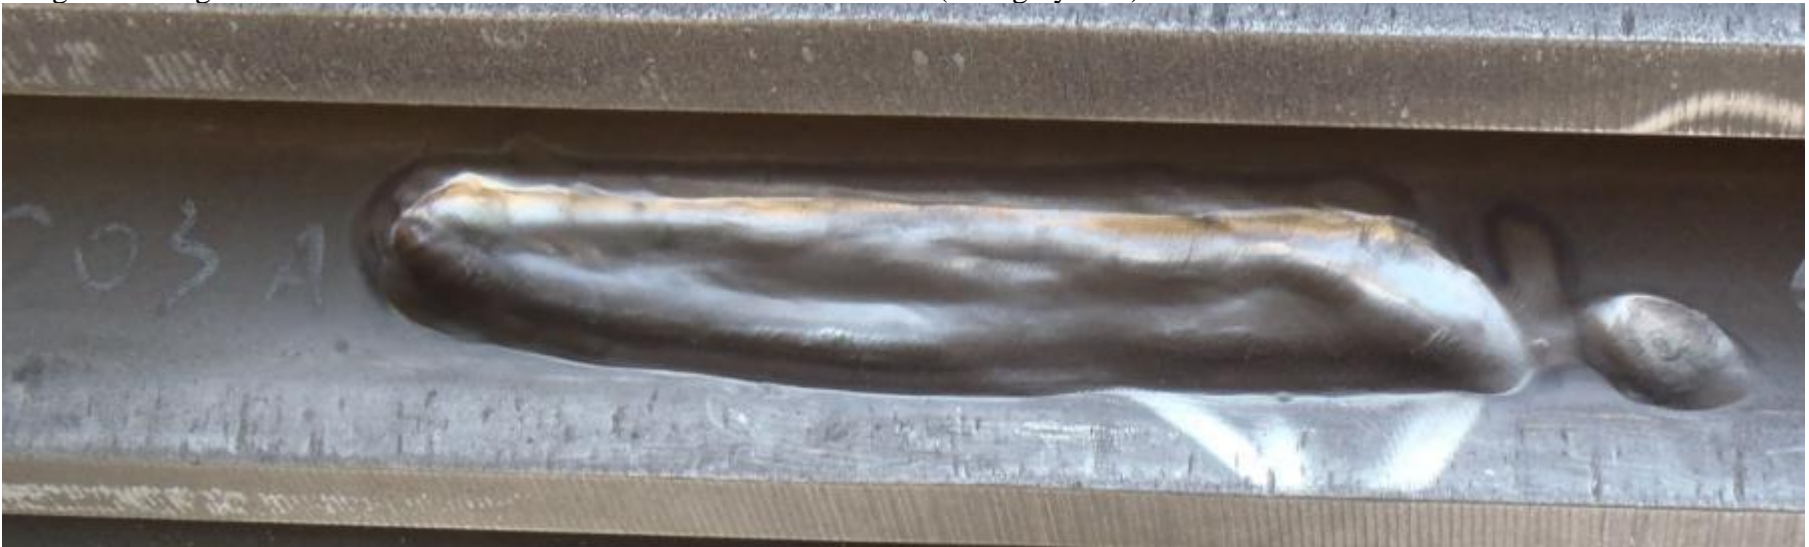
Fig 10 Final profile and surface finish of excavation

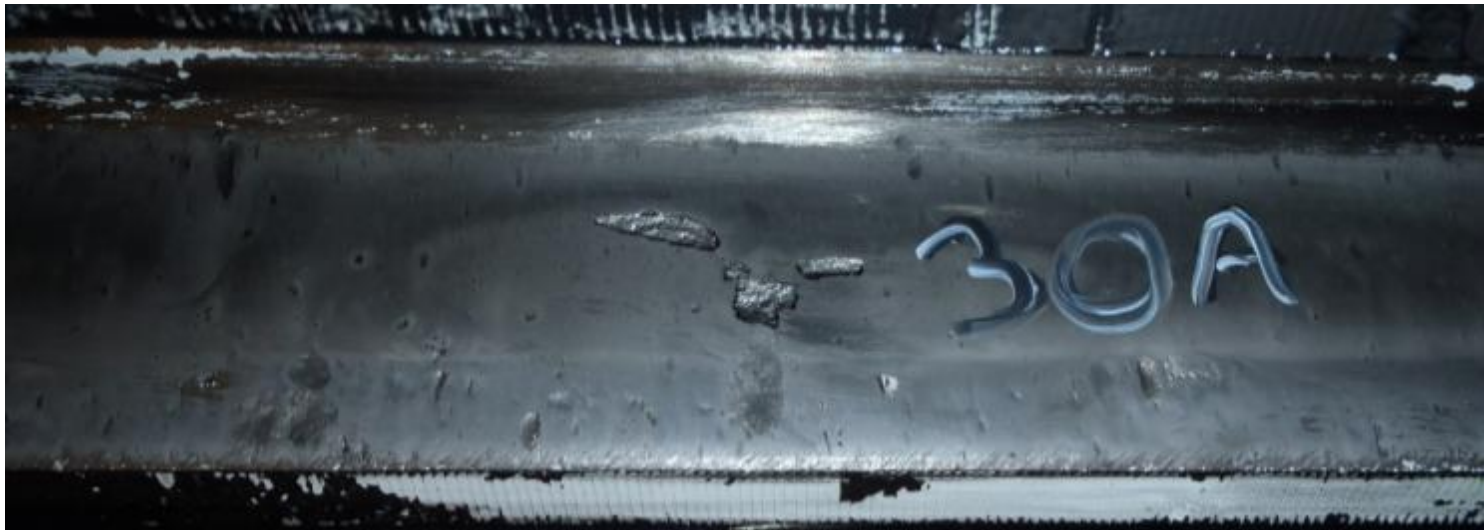
Fig 13 – Tooth 030A No noticeable change since 2011

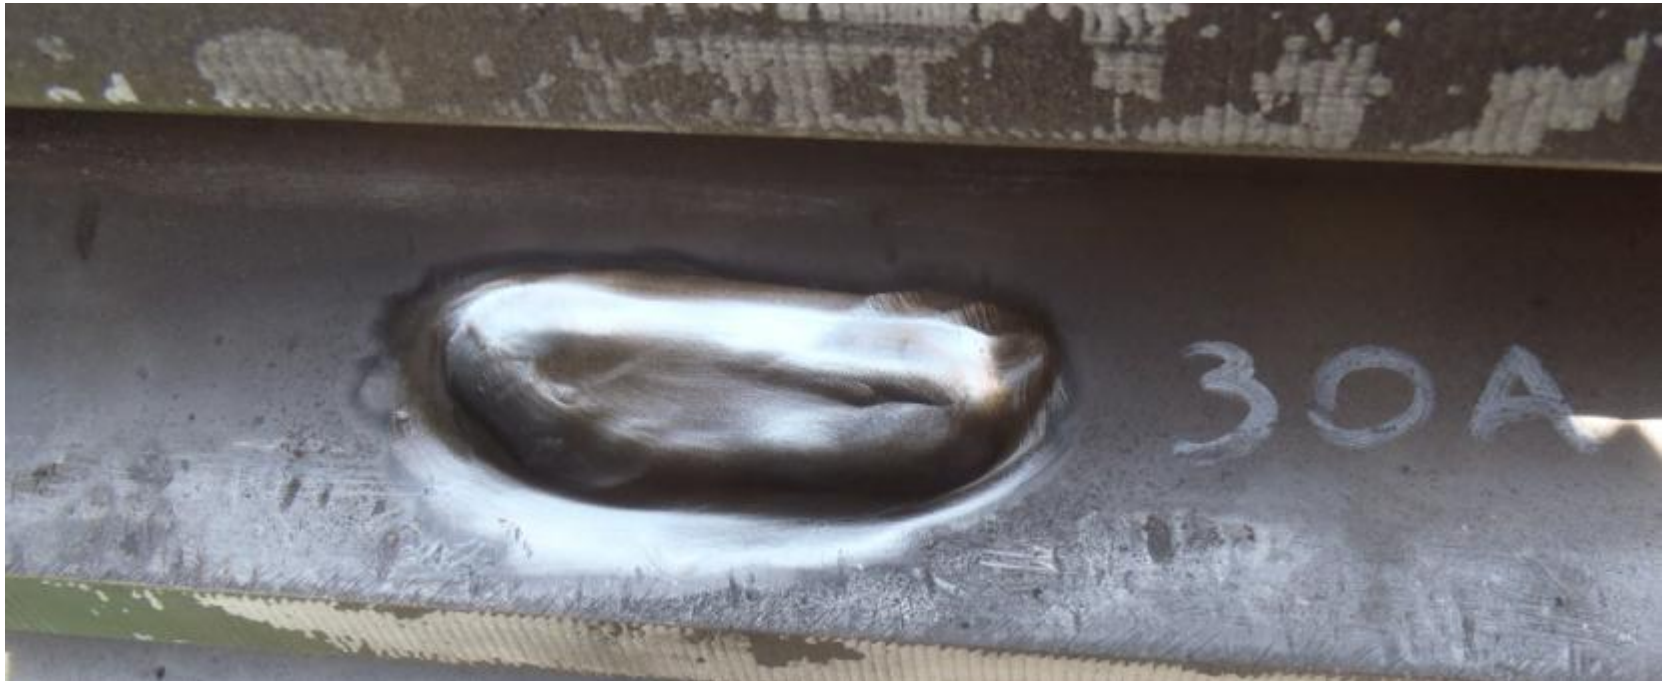
Fig 14 excavated and profiled tooth 30 A

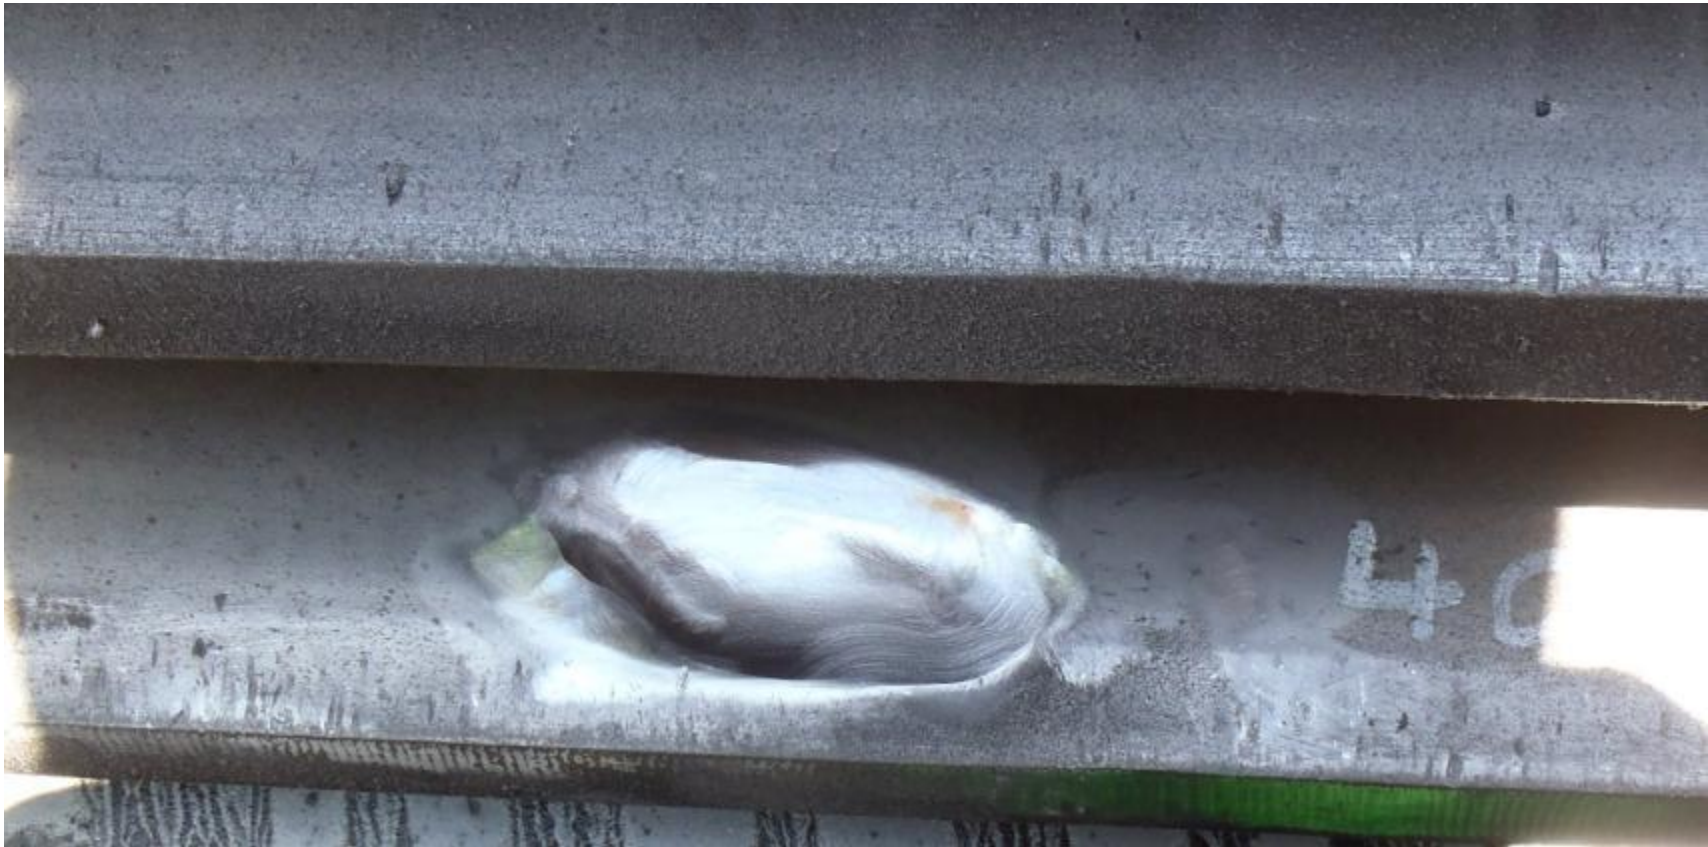
Fig 17 Tooth 40 excavation

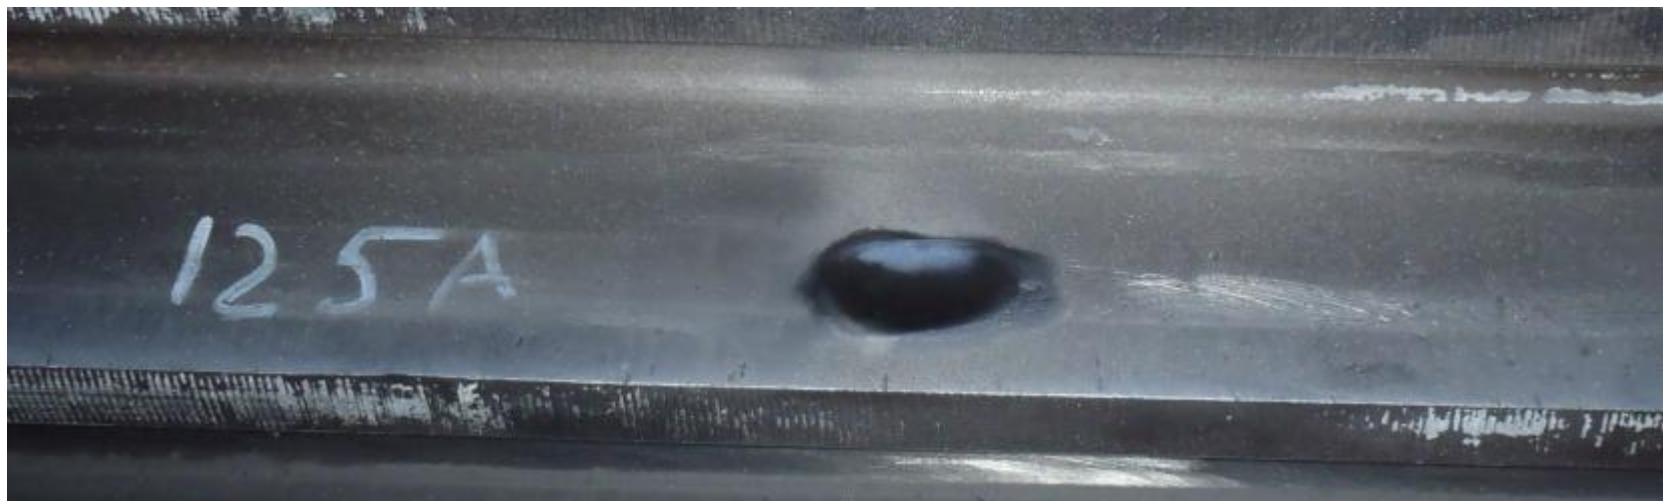
Fig 20 tooth 125 polished

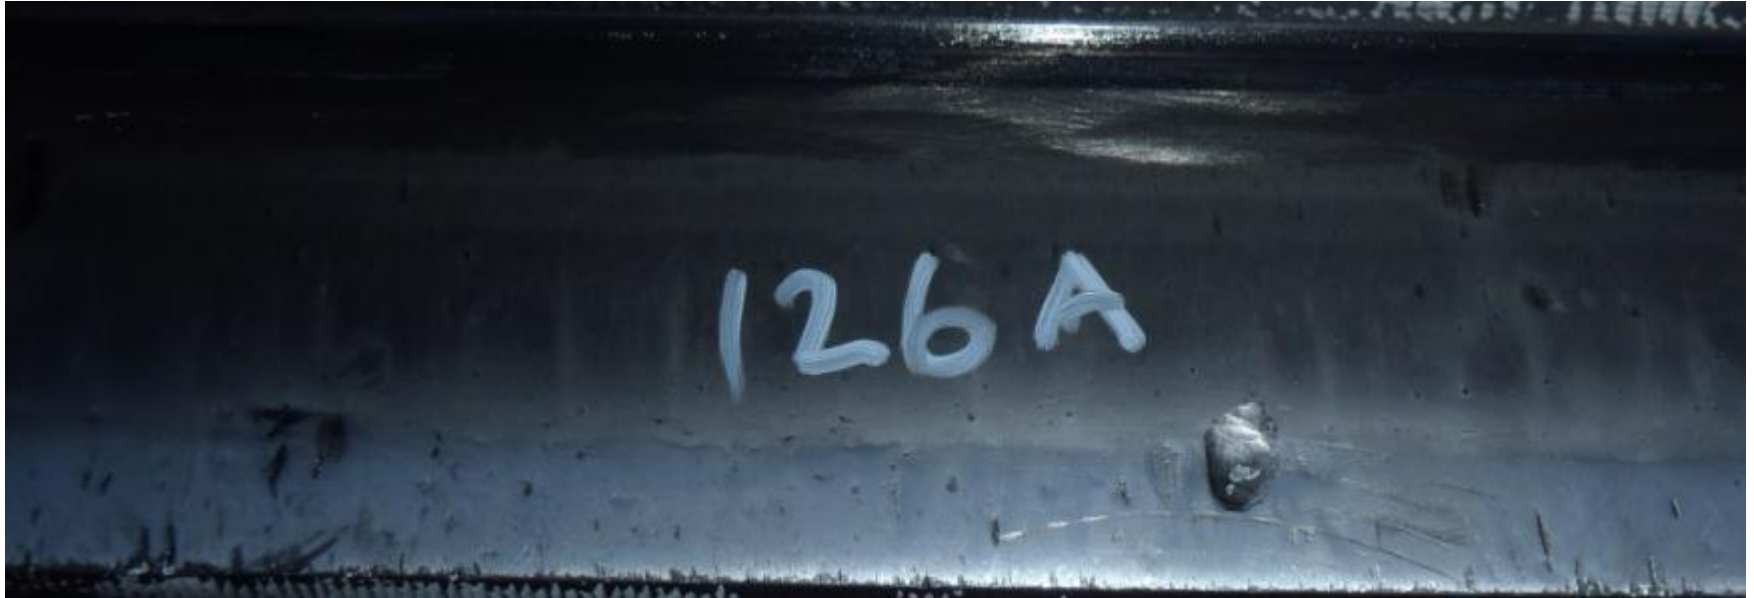
Fig 21 A and b Tooth 126A before and after

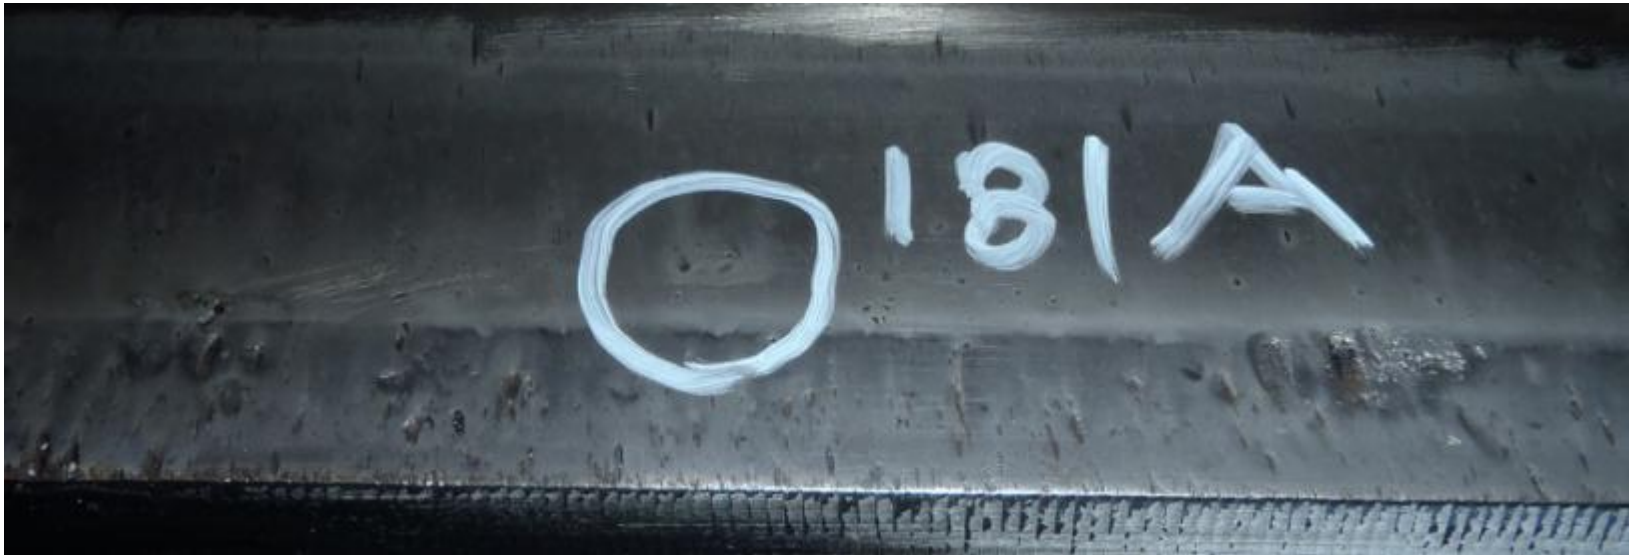
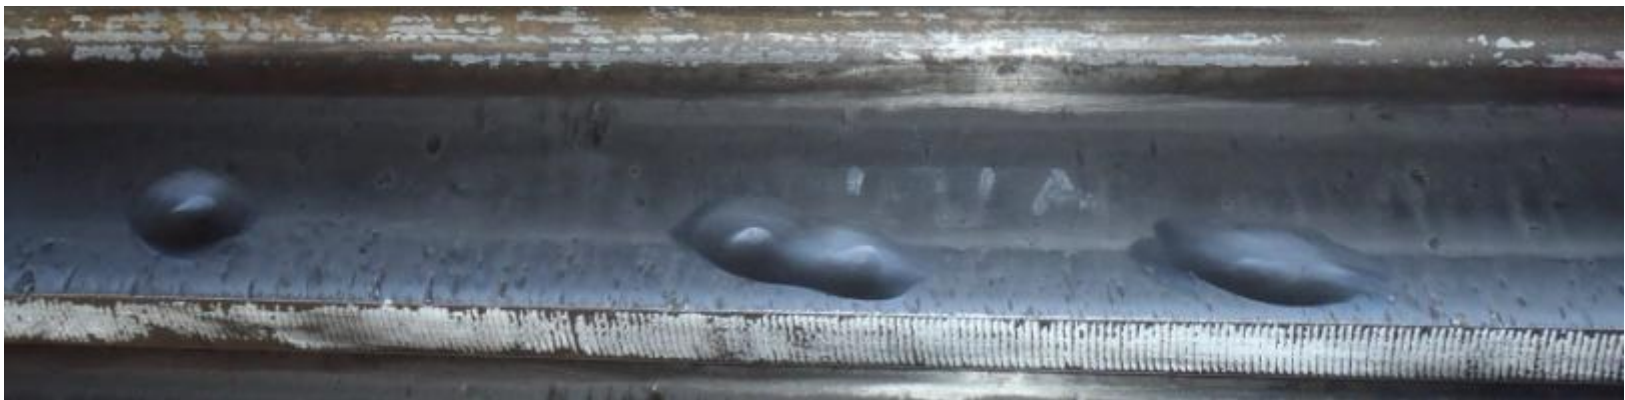
Fig 22a and b Tooth 181 A before and after

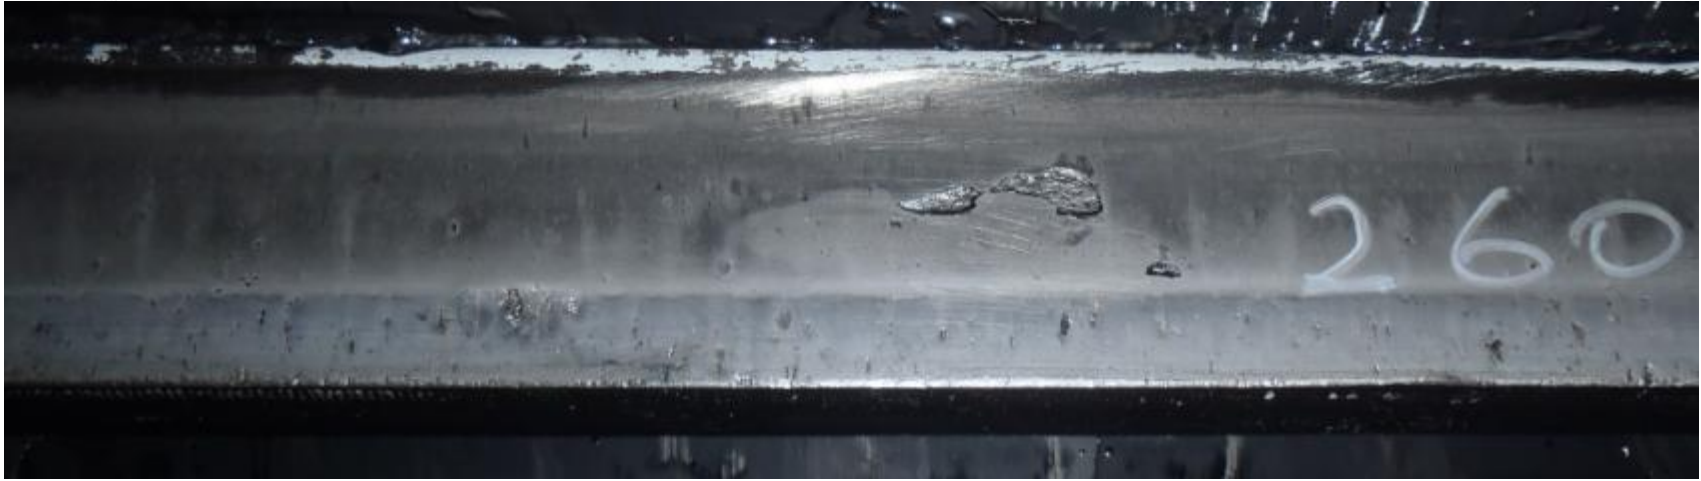
Fig 26a Tooth 260A 2013

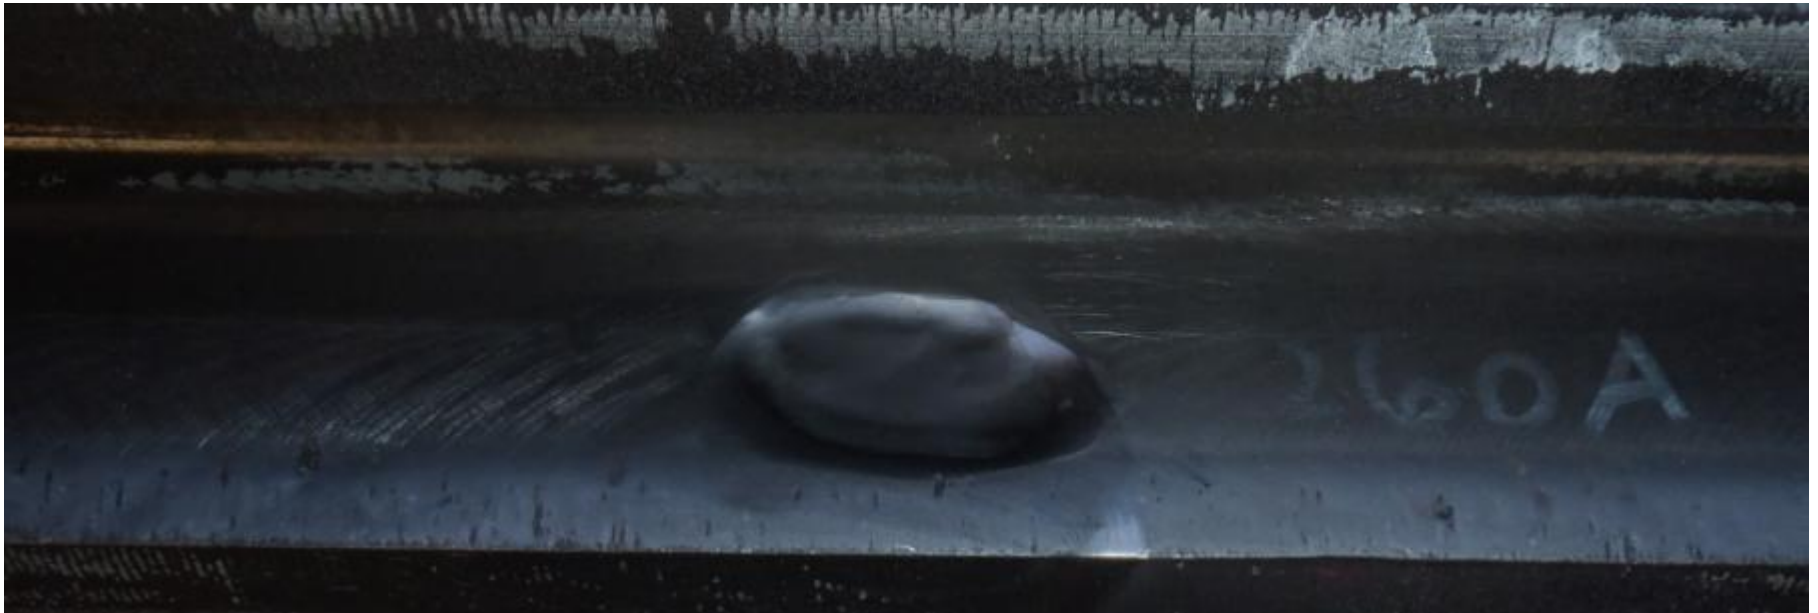
Fig 27 Tooth 260A remediated
