Client Mining Operation SAG Mill

Author	Justin Marwick	4 th December 2016
Client	Client	
Inspection Date		1 st December 2016
Order Number

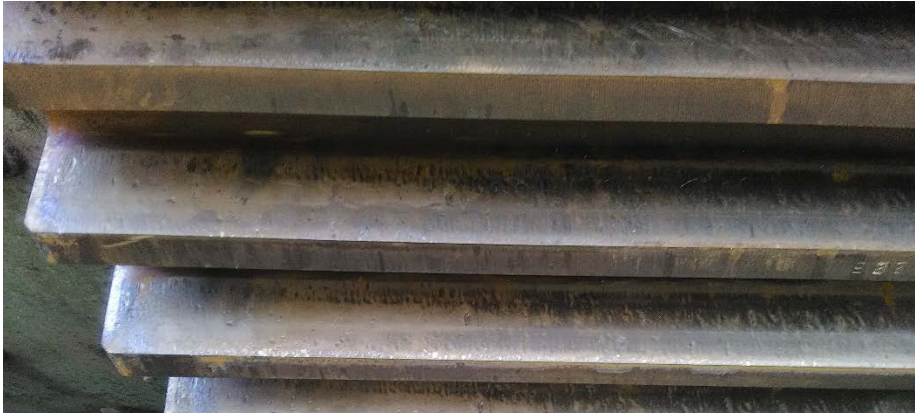
Contact between the pinion and the gear was noted to be more pronounced on the non-drive end than the drive end. An area at the drive end was noted that was indicative of abrasive contaminant ingress that removed material from both pinion and gear in that area.

Fig 1 Gear tooth cleaned before remedial work commenced (Drive end).

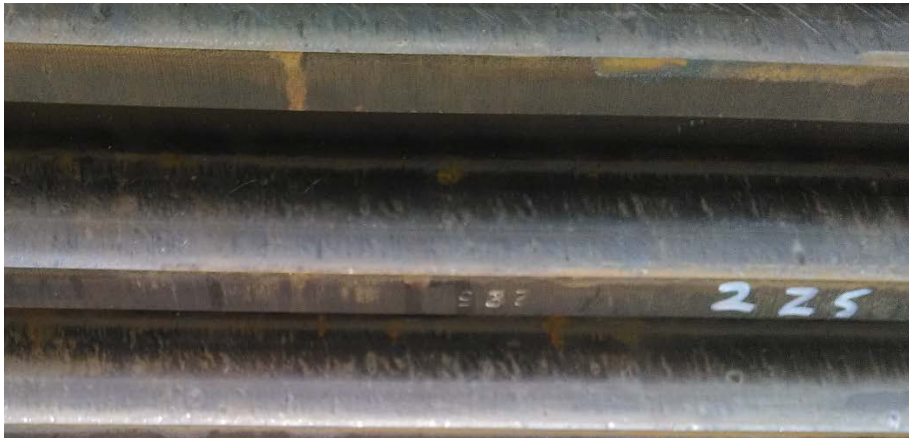
Fig 2 Centre section of the un-remediated gear tooth.

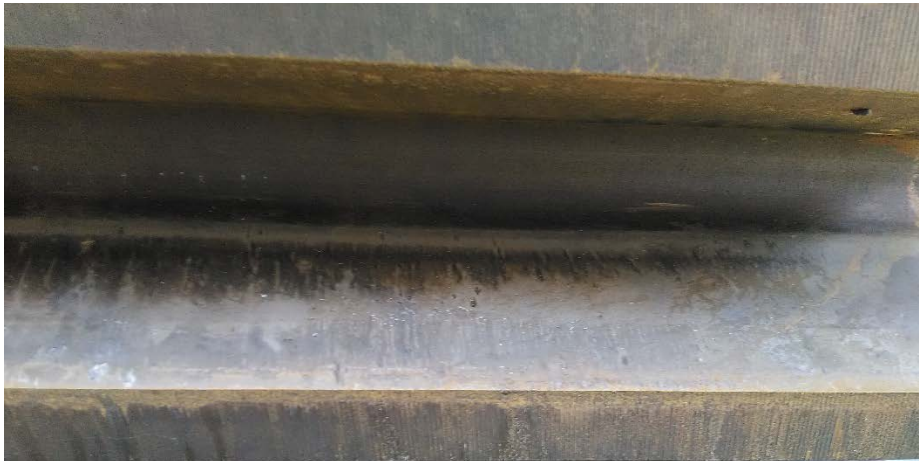
Fig 3 Non drive end of girth gear before remedial work.

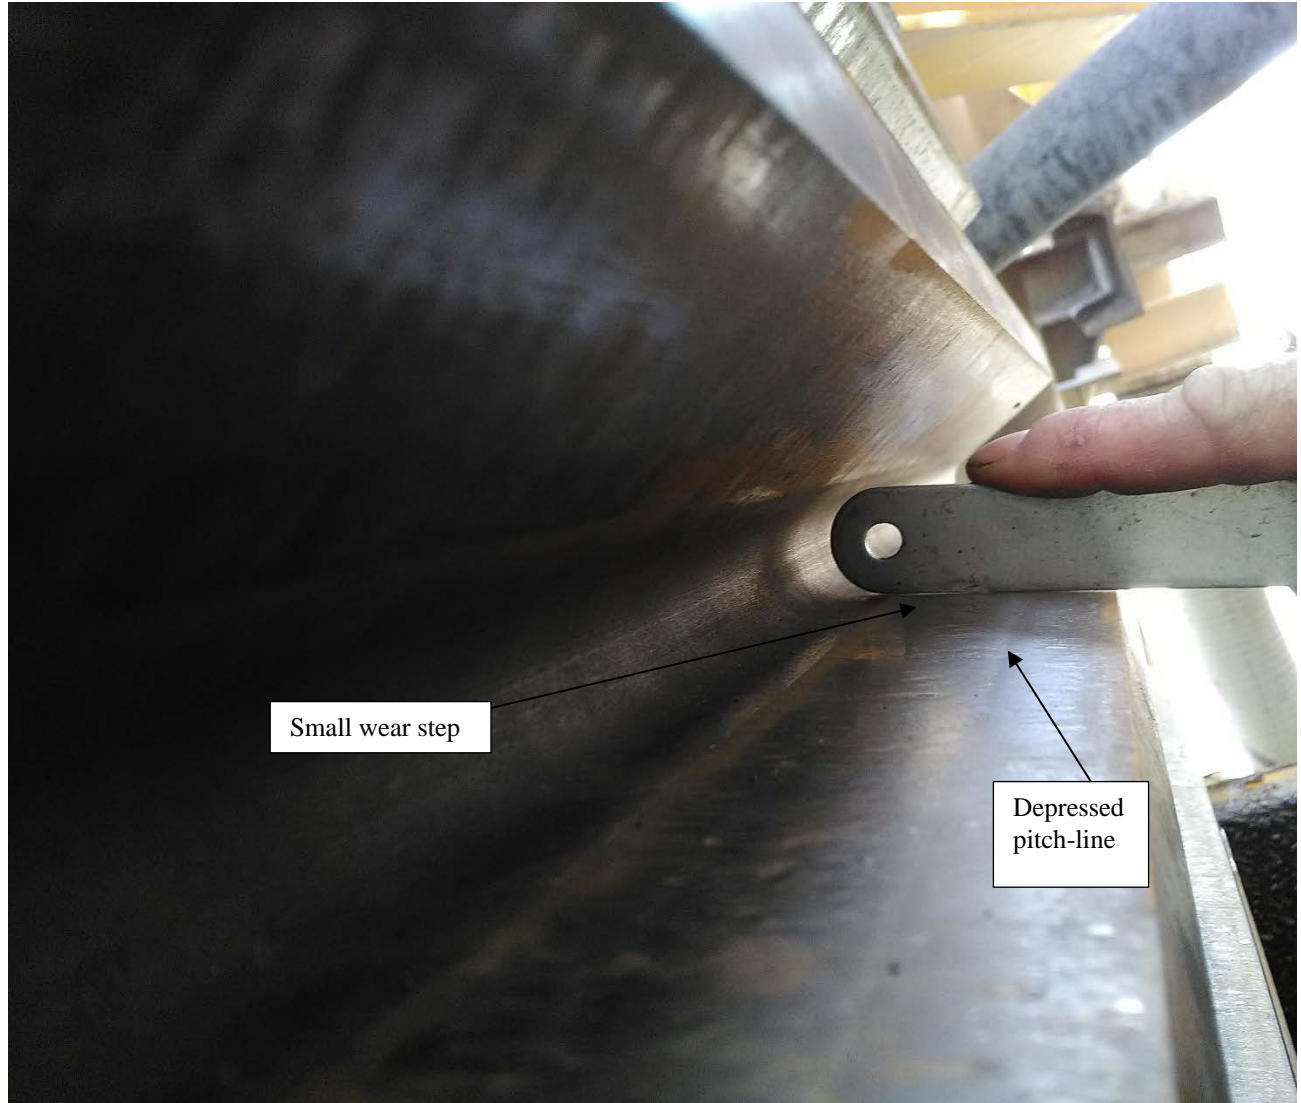
Fig 4 involute profile before hand finishing of the gear.

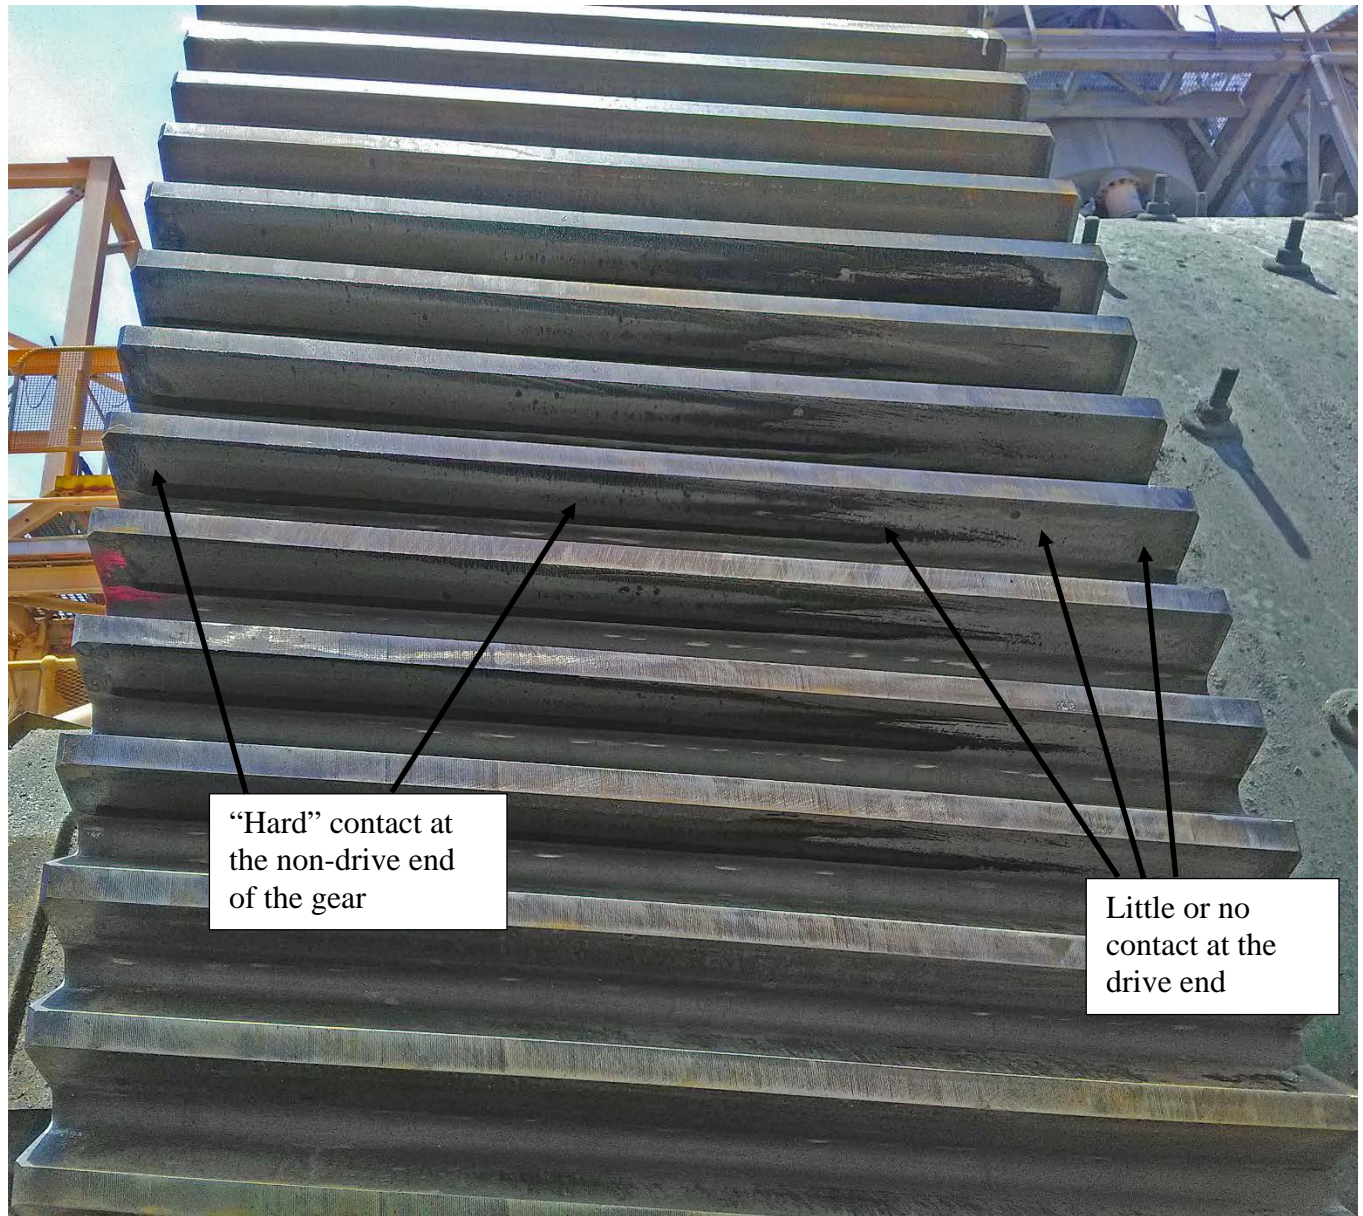
Fig 5 - Contact **before** hand finishing the contact obviously tends toward the non drive end with a transition about 2/3 of the way across evidenced by the remnant bearing blue and the area at the drive end which shows no blue is because the clearance is too great to leave any blue on the gear surface.

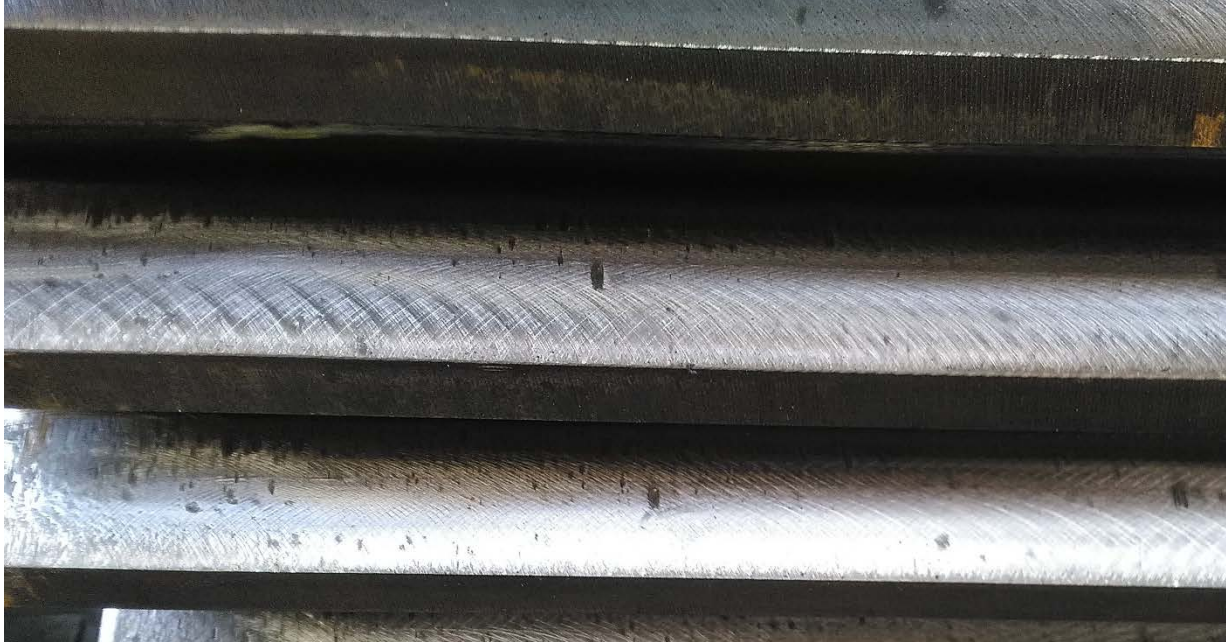
Fig 6 Dive end contact flank **after** hand finishing.

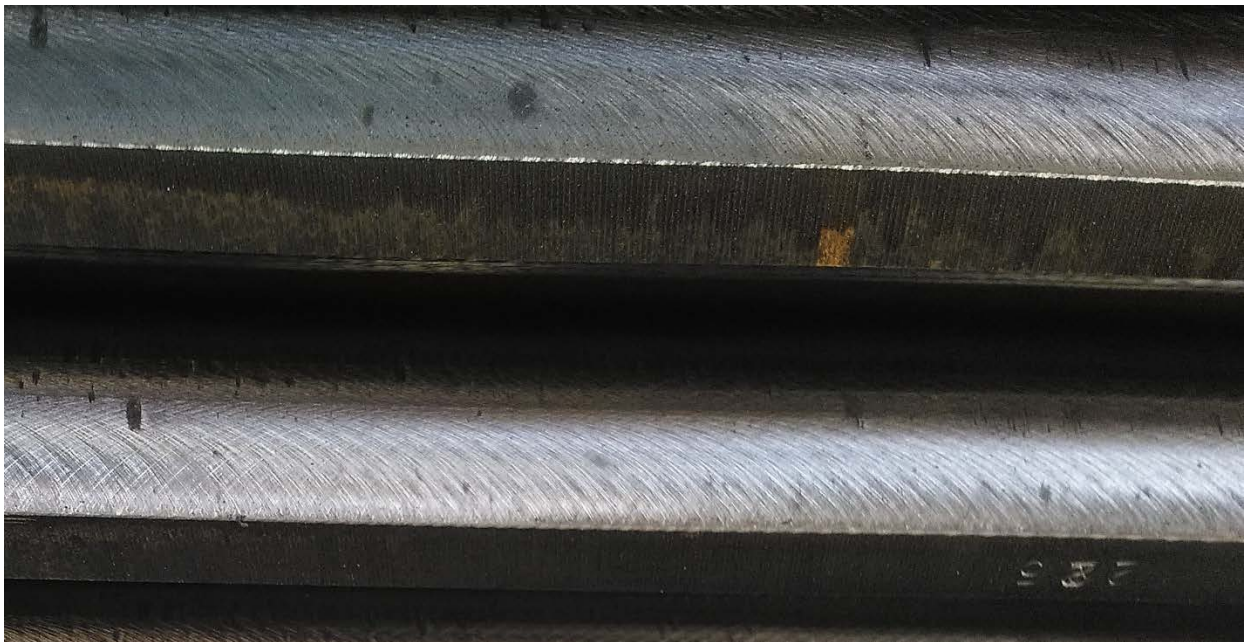
Fig 7 Centre region contact flank **after** hand finishing.

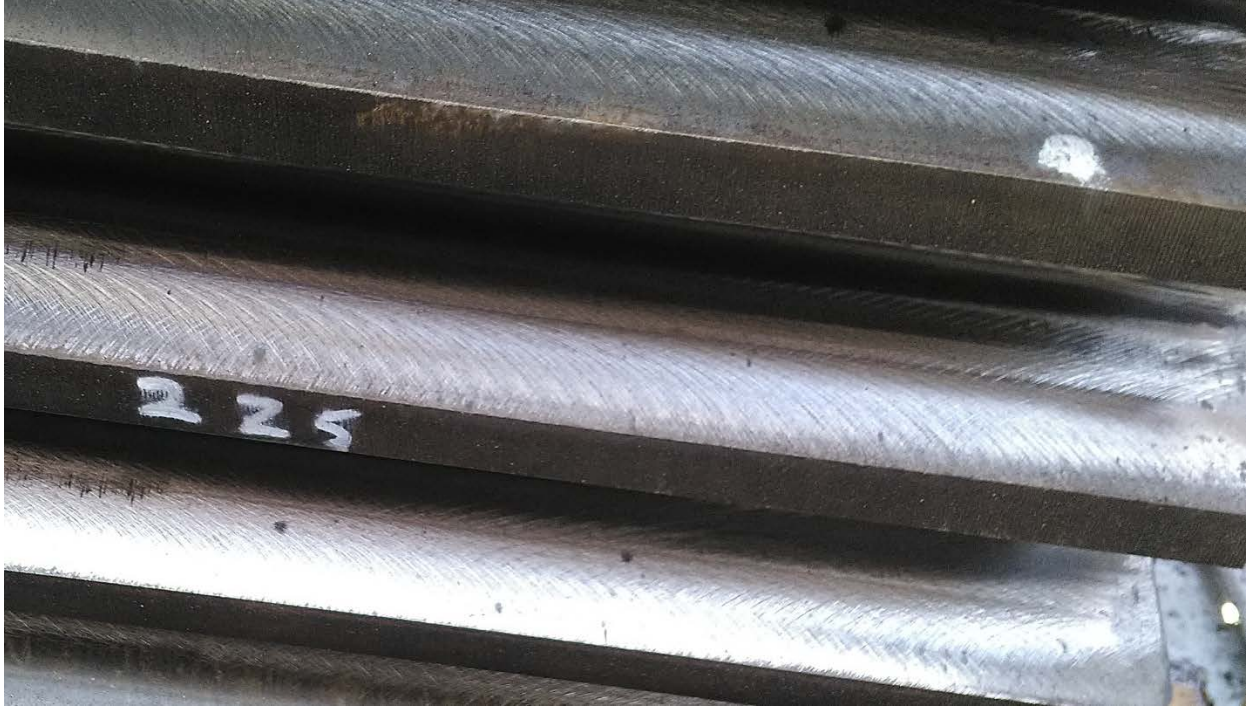
Fig 8: tooth 225 non drive end after finishing

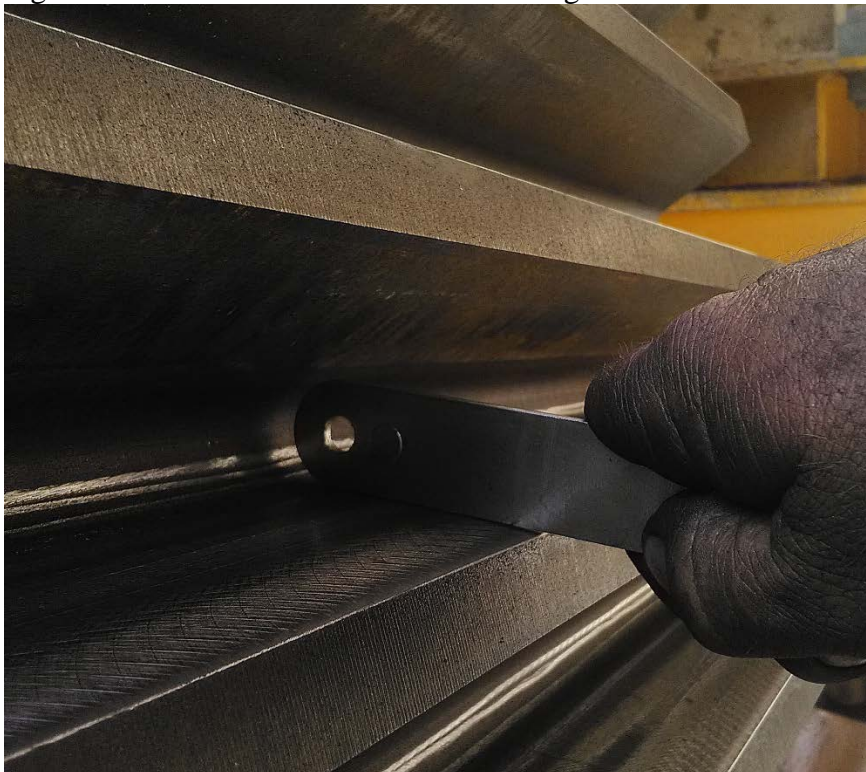
Fig 9: View of profile after finishing – some of the wear step has been taken down.

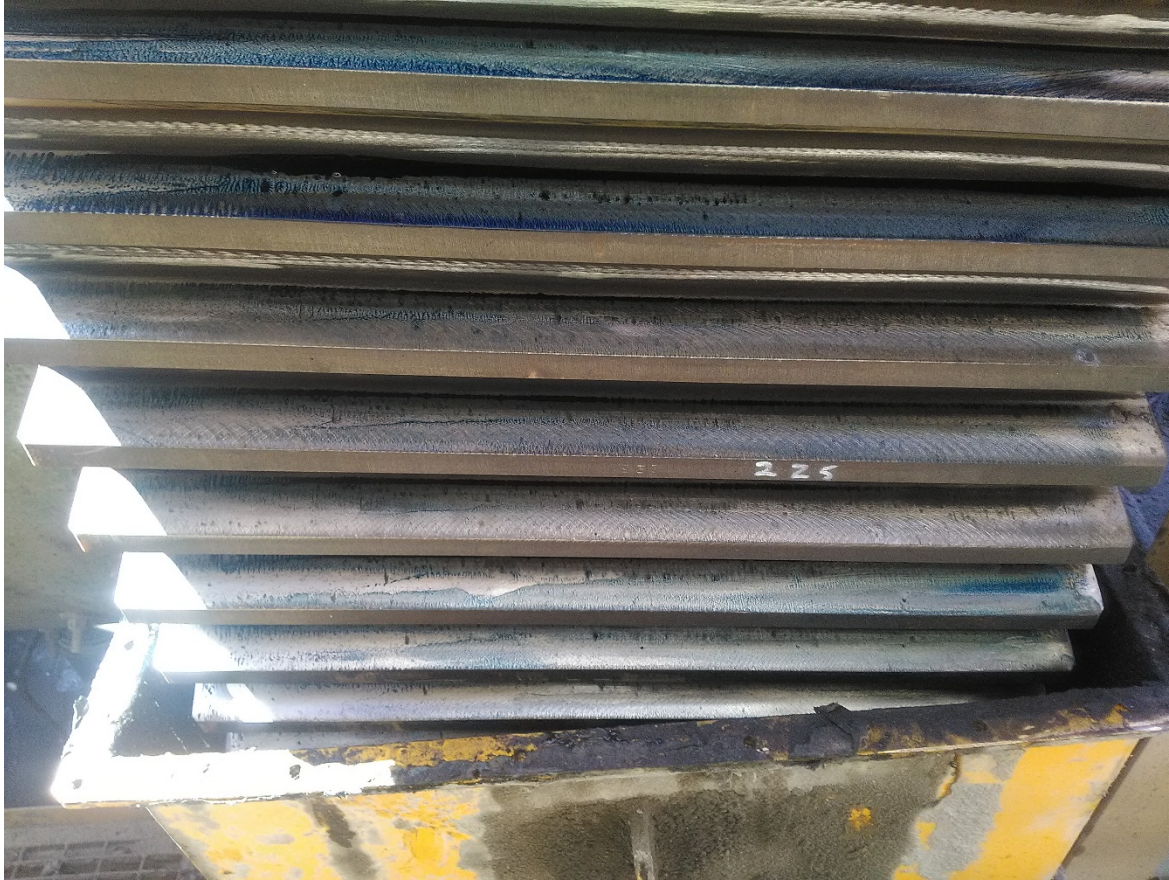
Fig 10: Contact after finishing showing relatively even contact across the tooth the drive end is on the left side of the picture. The contractor will to make some pinion adjustments after the trunnion bearing change.

The hand finishing appears to have restored contact area on the gear; a pinion alignment adjustment was understood to be carried out before the mill was returned to service. This will further improve the load distribution across the teeth.
