A GOLDMINE GOLD A goldmine Gold Mine Sag Mill

Author	Justin Marwick	22 nd August 2016
Reviewed	Brendan Wicks	23 rd August 2016
Client	A goldmine Mining	A goldmine Gold
Inspection Date		17 th August 2016
Order Number	Purchase Order No

NDT and inspection of A goldmine Gold mining's – A goldmine Gold mines Sag Mill girth gear. The principal objective is the detection of fatigue cracking that poses a risk to the continued operation of the ball mill and report significant anomalies.

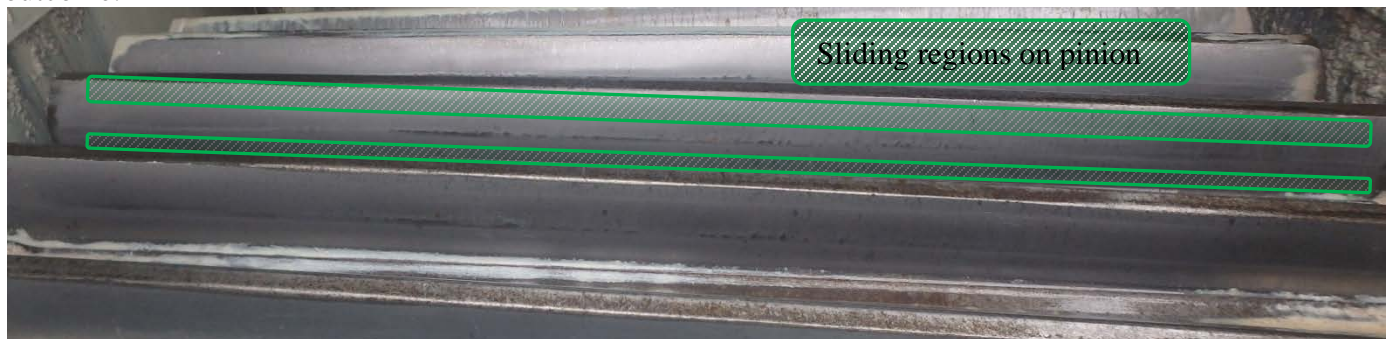
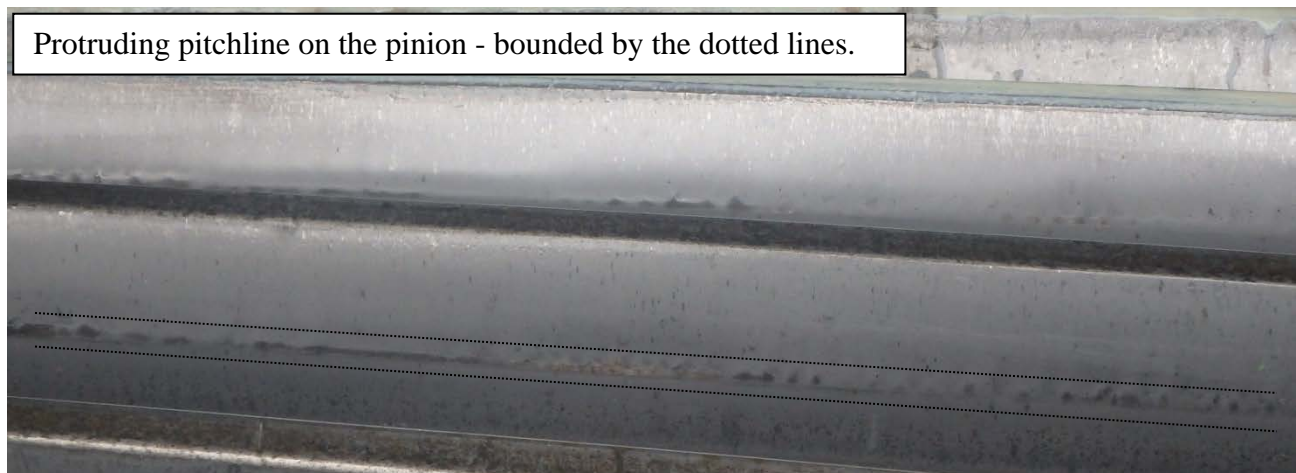
The girth gear has a depressed pitch line. This coincides with a slightly raised pitch line on the pinion gear. This would normally indicate that significant wear has taken place with a relatively soft pinion driving the gear. Wear happens in the addendum and de-dendum areas of the gear set. Once the abrasion or wear has taken place it leaves a high pitch line due to the rolling action of the gears.

It would be advisable to remove the protruding pitchline on the pinion by means of a sander and oilstone. Once the pinion geometry is improved - then the deterioration on the girth gear associated with load concentration will be reduced. In the long run (sometime in the next 1 - 2 years) it would be advisable to do the same for the girth gear and reverse the pinion to provide a good medium term outcome.

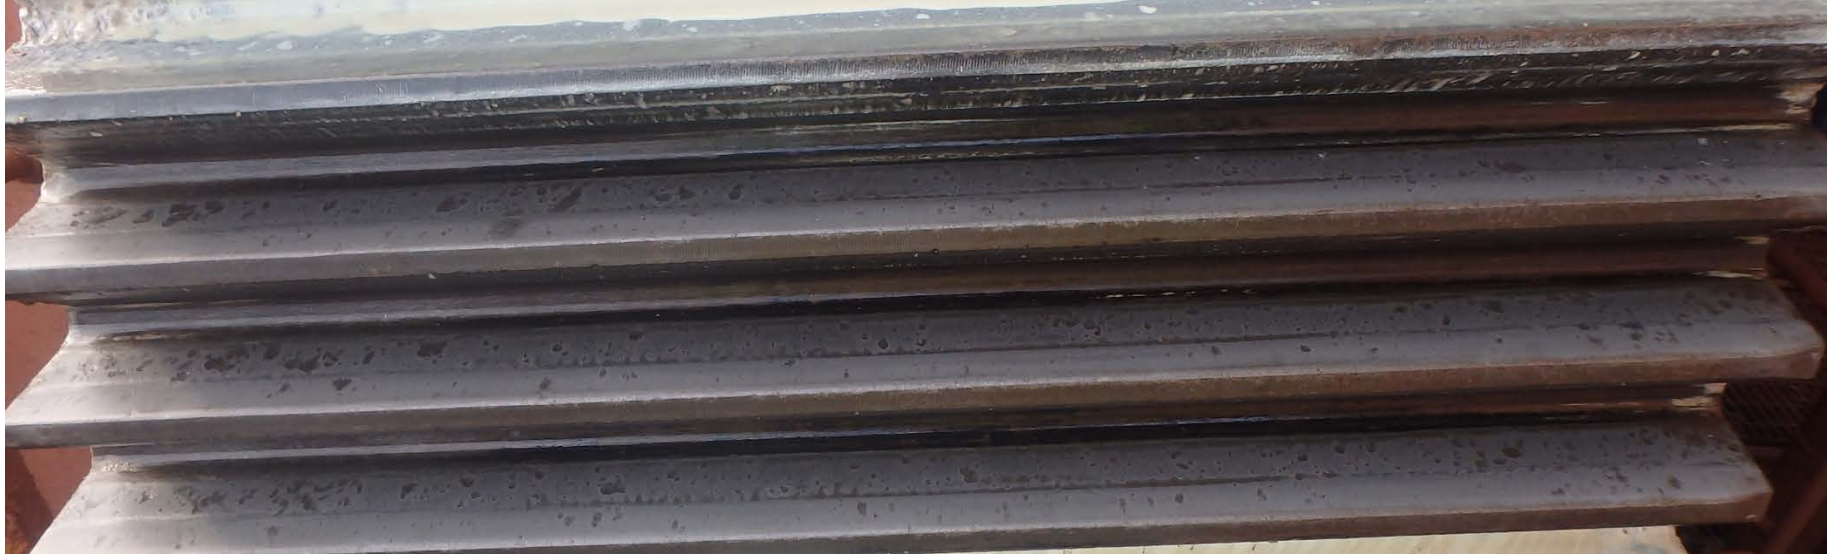
General view of contact flank.
