A mine Mining LTD

SAG 2 GEAR FAILURE REPORT REVIEW

Date 10th December 2020	Author	Justin Marwick
	Notes and Review

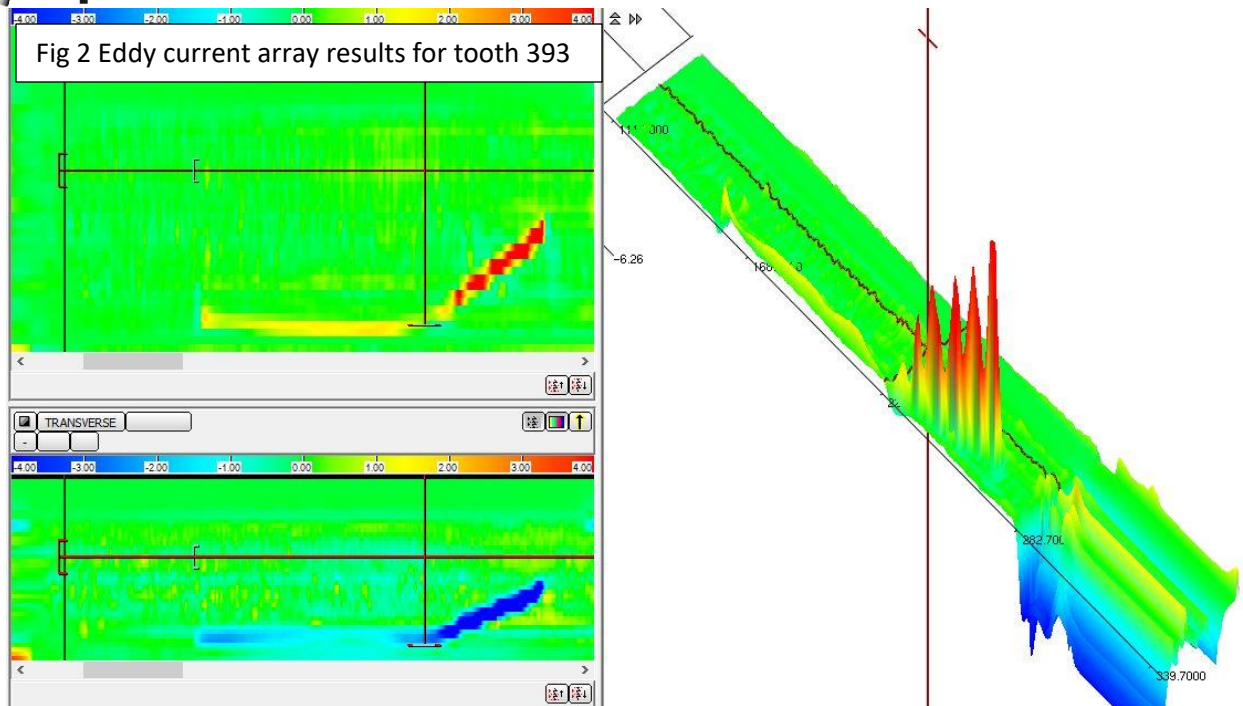
Hofmann engineering were contacted to effect a remediation or an amelioration of the gear tooth with whatever techniques they had available.

The gear was removed from service in March 2020. A new forged and fabricated gear was installed along with new pinions and an improved gear sealing arrangement.

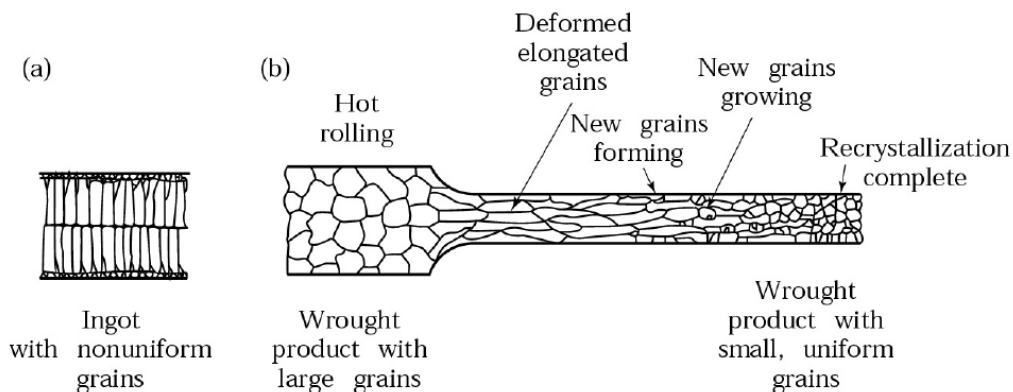
Fig 6 hot rolling taken from Materials notes by Dr Valerie Speredelozzi

The issues the author describes regarding the poor tribological properties of the low carbon steel used in the manufacture of the fabricated gears have been noted in the past and leads to accelerated wear and compromise of the involute profile (galling and welding when lubricant is not sufficient are also problems).
