Goldmine

Author	Justin Marwick	
Review and notes	Brendan Wicks	11/10/2013
Client	Goldmine	Gold Company
Repair date	Ball Mill

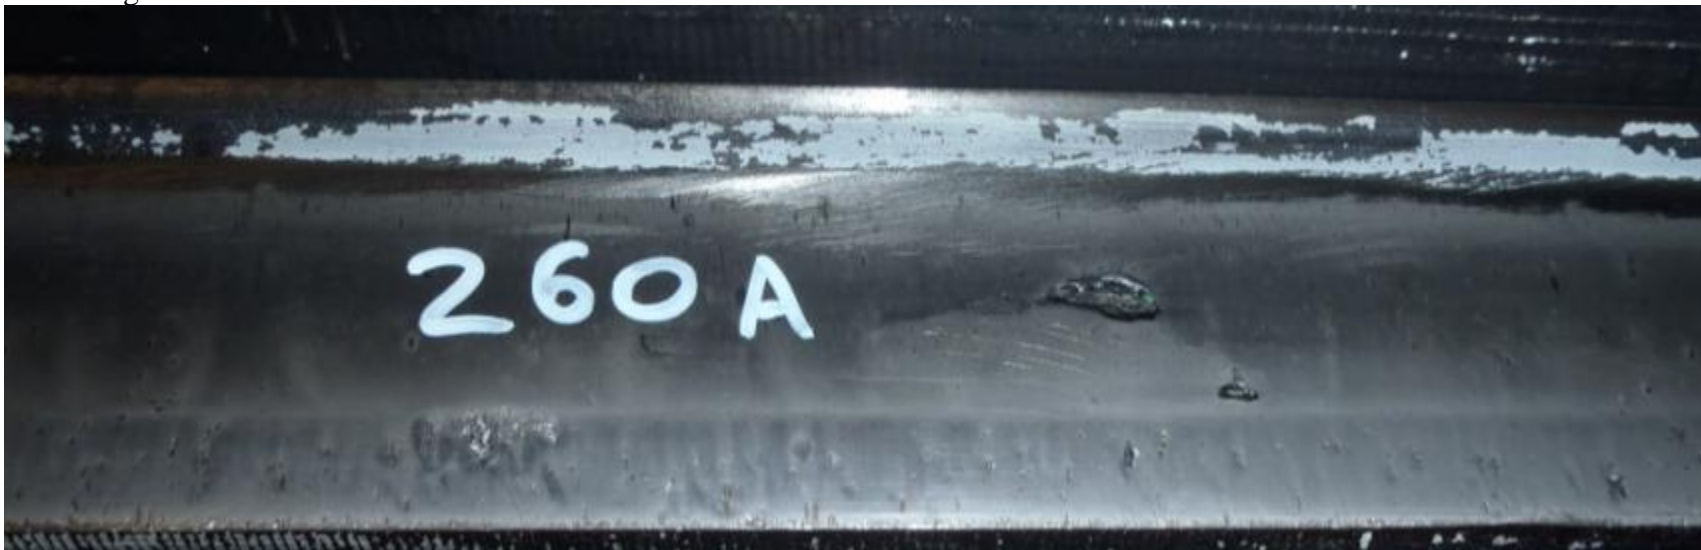
Fig 26 b Tooth 260A 2011

Tooth 003A (load side of tooth number 3) has experienced noticeable deterioration where some localised spalling has expanded and evidence of fatigue over the local region was evident. Tooth 260 A had also deteriorated where additional fatigue spalls had fallen from the gear surface. Both of these gear teeth have been remediated by profiling the fatigued material and polishing the excavated surface to prevent crack re-initiation.
